XXXXXX 9876

● Statistics 1

Prepared by: Jerry Salontay

Ohio Home Inspectors LLC.

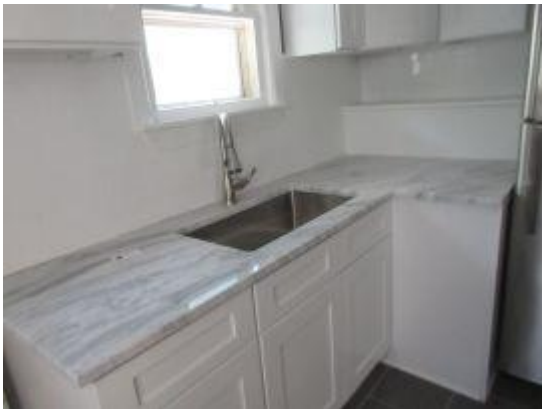
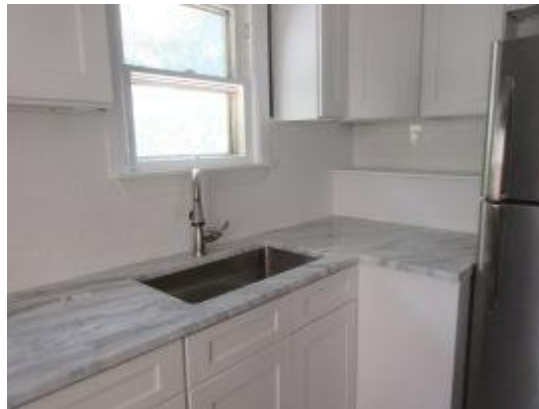
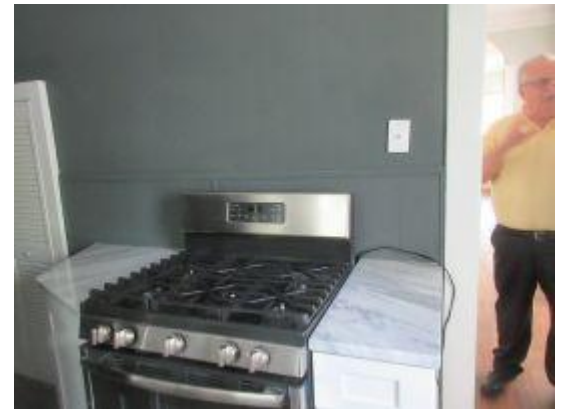
Kitchen. There are no counter top receptacles in the kitchen. Since the kitchen is newly remodeled it should follow current guidelines. For receptacle layout as shown above. All should be GFCI protected the stove too needs a receptacle The stove and the refrigerator need to be assembled. Since they were not assembled they could not be observed working.

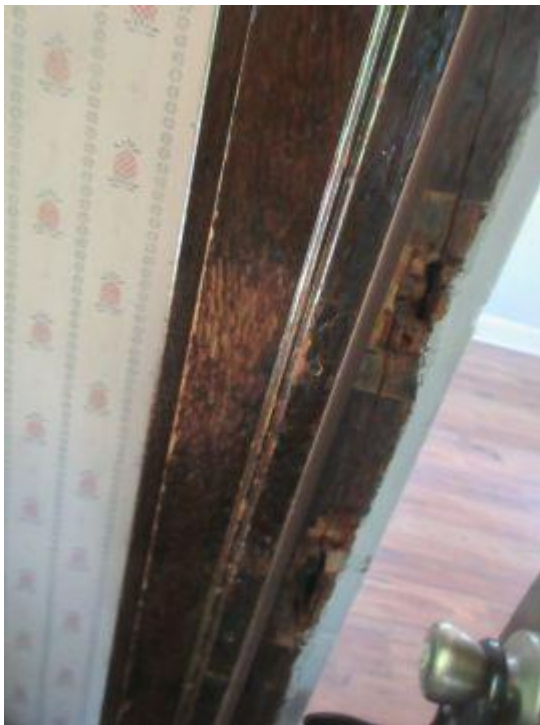
Living Room 1236. On the front door the dead bolt is inoperable and both latch plates are missing.

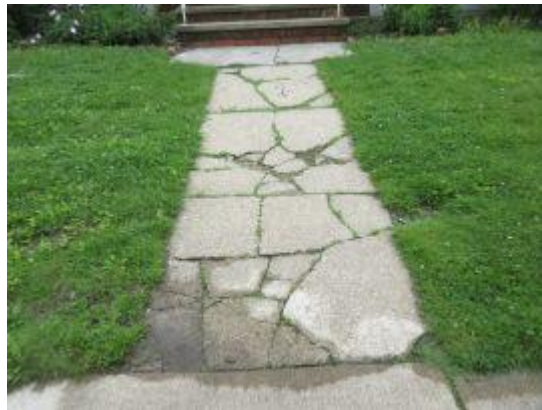
~~Site. The front private sidewalk has experienced major cracking and shifting that may be considered a trip hazard.

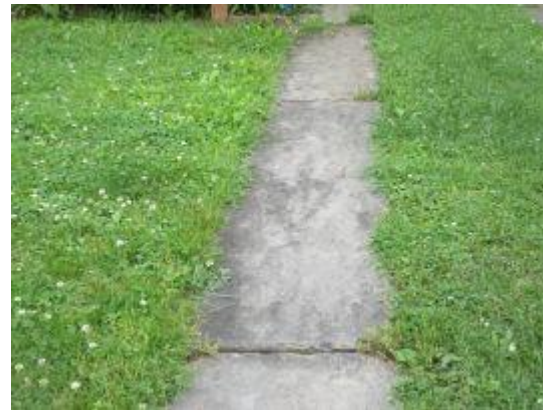
~~Site. The front private sandstone sidewalk has experienced some shifting that may be considered a trip hazard.

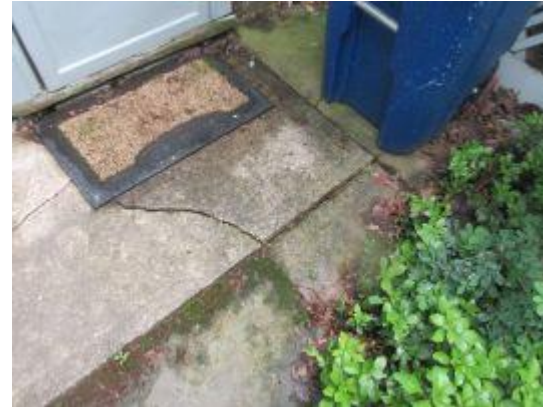
Site. The rear sidewalk area is cracked and shifted and may be considered a trip hazard.

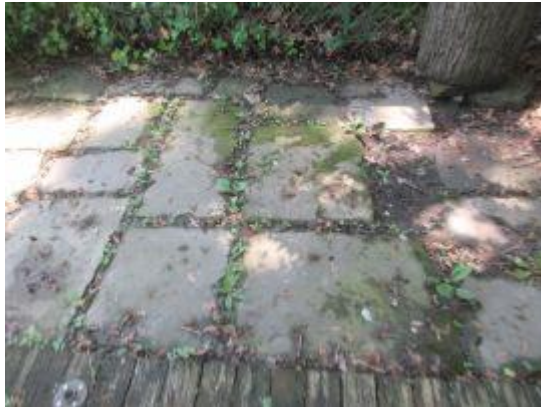
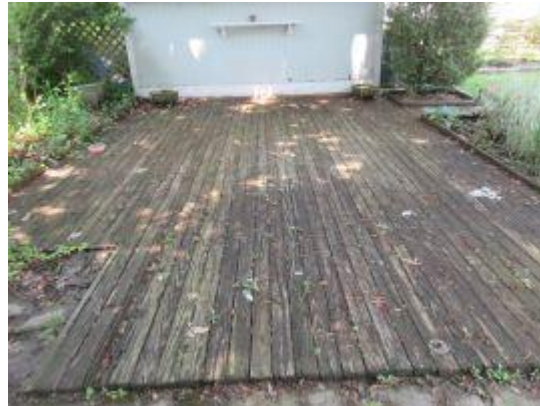
Site rear. There is a patio area in the rear yard. Wood should not be in direct contact with earth. It appears currently intact. Some areas of the patio may be considered trip hazards.

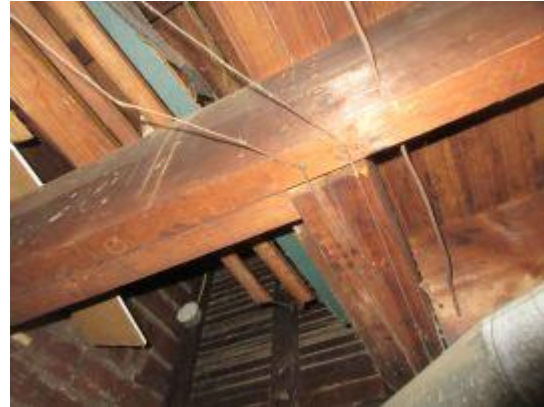
Structure. In both apartments joist hangers are lacking. At time of construction they were not required. No ill effects were noted.

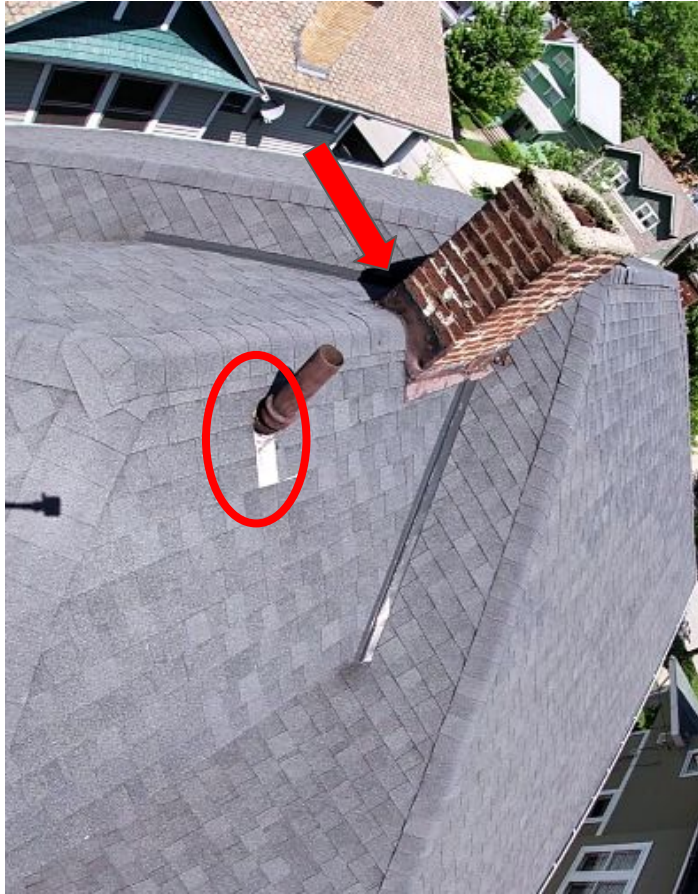
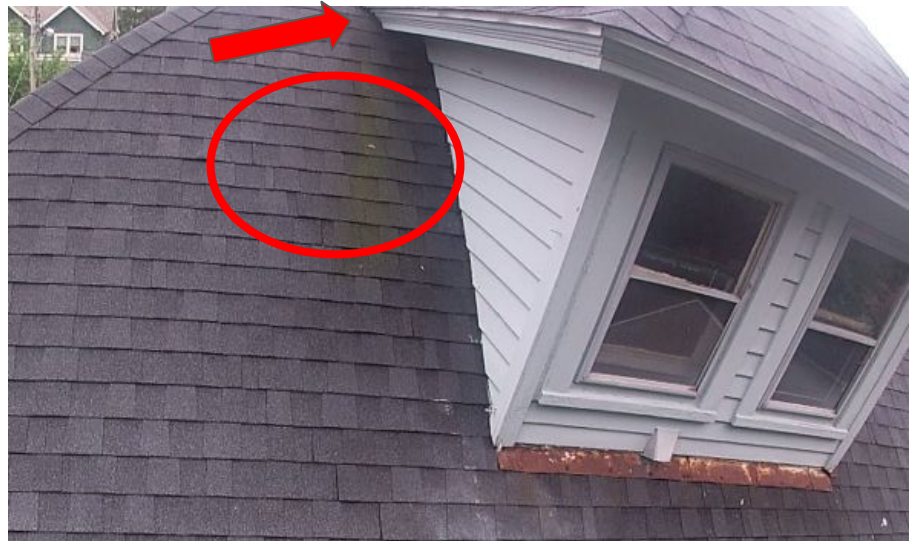
Roofing. In general the roof seems in good shape. There are many water marks. Likely the watermarks are from the time prior to the latest roof installation. Likely it was a slate roof.

There are two areas that appear to currently leak. Both are circled in red below. In apartment 1236 the stack pipe appears to leak. It does not appear to have a proper boot. The other one is in apartment 1234; it is not certain as where the leak originates. The red arrows are showing likely areas. Likely it leaks at the flashing and if properly roofed there is likely much of a iceguard like material in this area. This likely directs the water to the leak area.

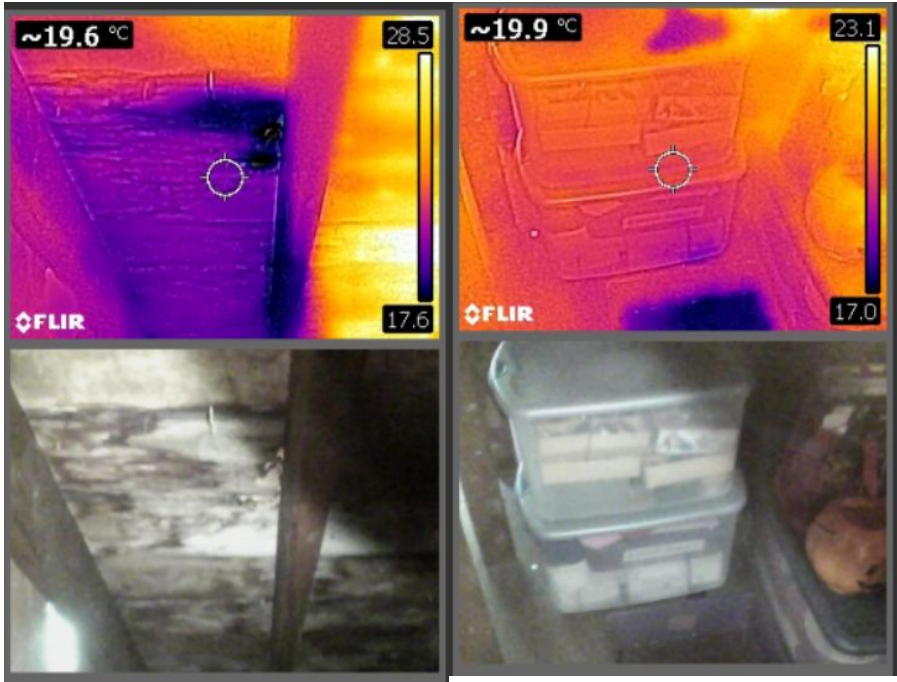
Roofing. Thermal imaging of leak areas in 1234. The conditions were not the most optimum for the evaporation of water. This may result in the masking of other damp areas.

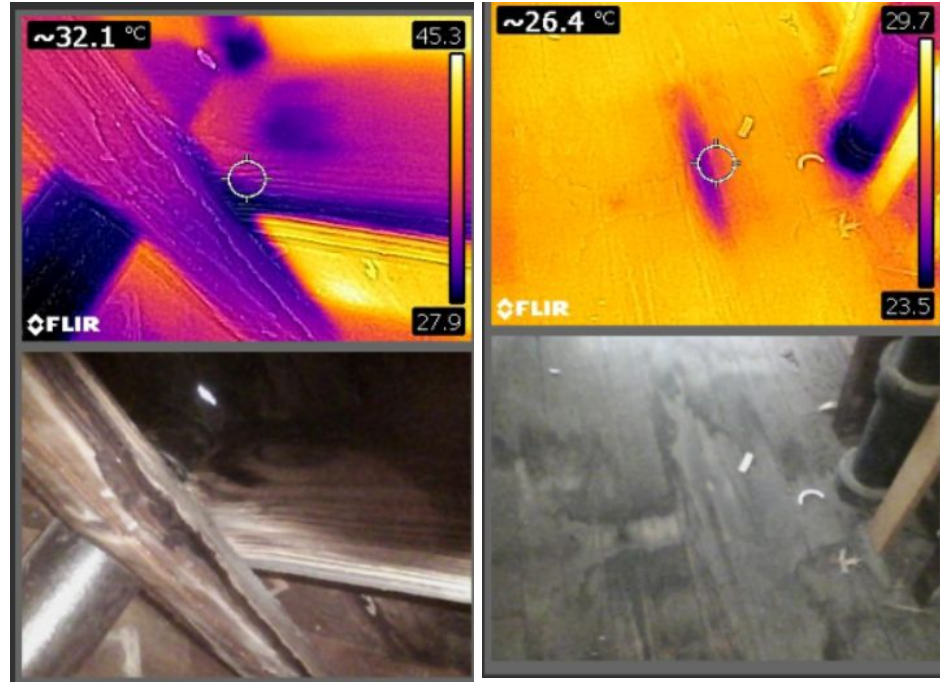
Roofing. Thermal imaging of leak areas in 1236. The conditions were not the most optimum for the evaporation of water. This may result in the masking of other damp areas.

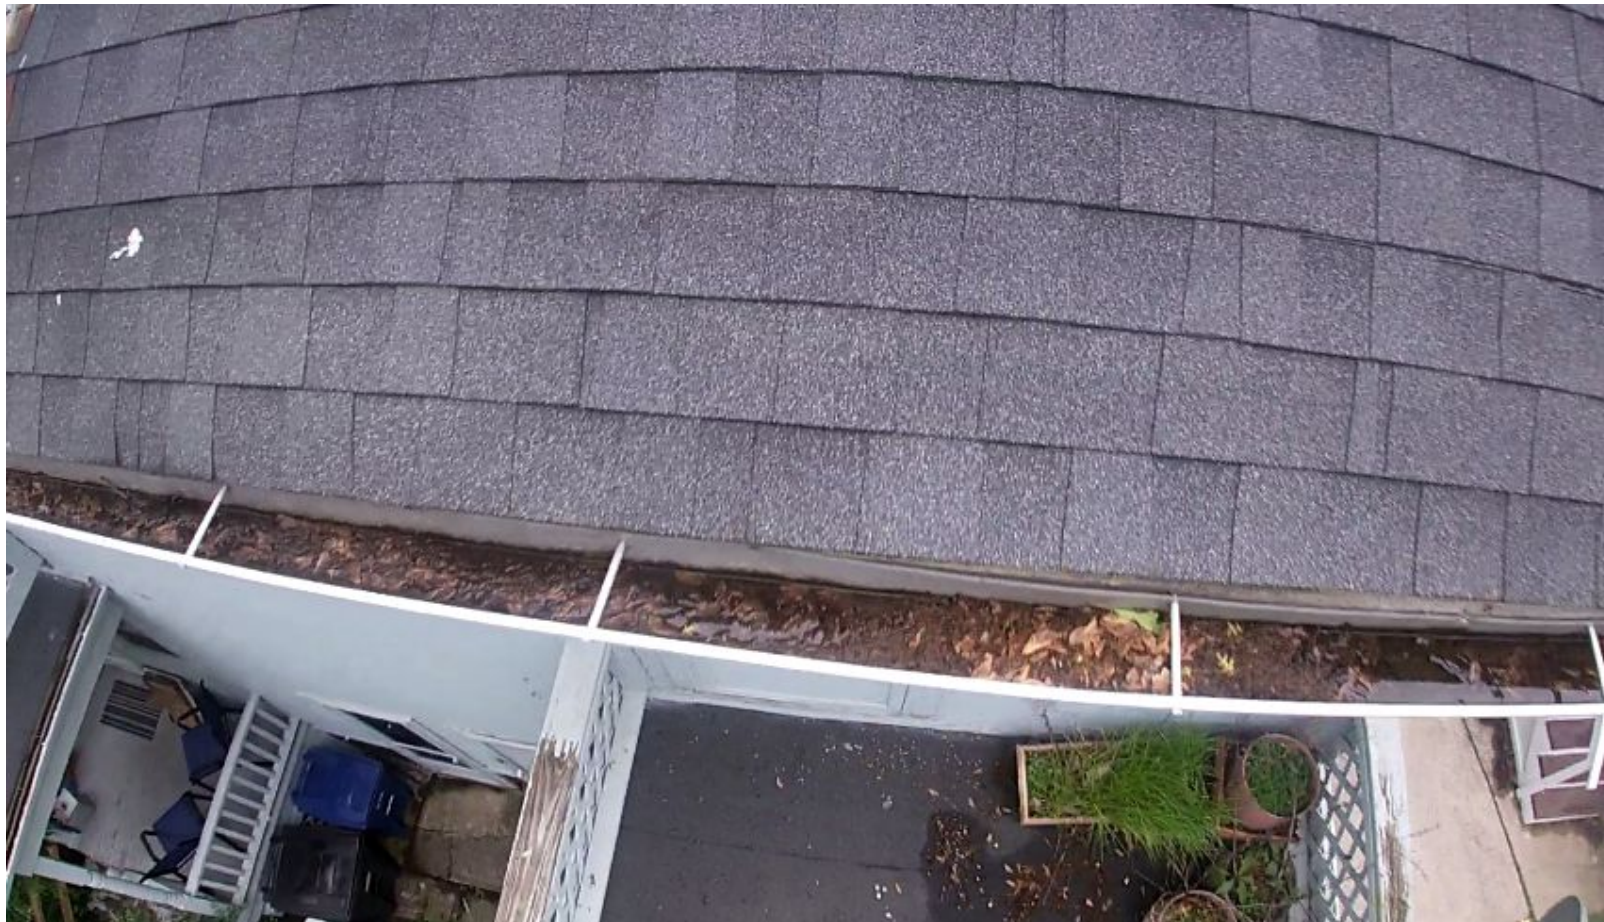
Roofing. There are several areas where the gutters would benefit from cleaning.

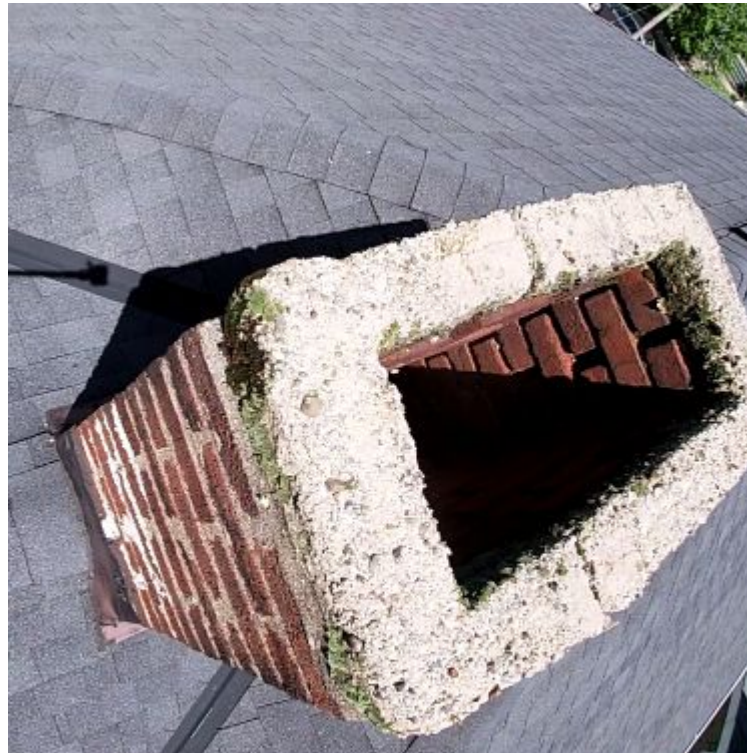
Chimney. The rear chimney has a major defect in that it has no ceramic flue liner. This chimney is in use for both furnaces and hot water tanks. Installing "B" vent liners may be the best fix. It may be necessary to brace the chimney above the roof line. Until this deficiency is removed smoke/co detectors should be installed on every floor in every suite near the chimney.(further comment in furnace section)

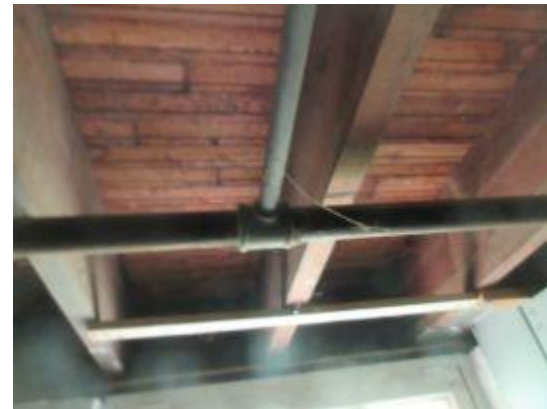
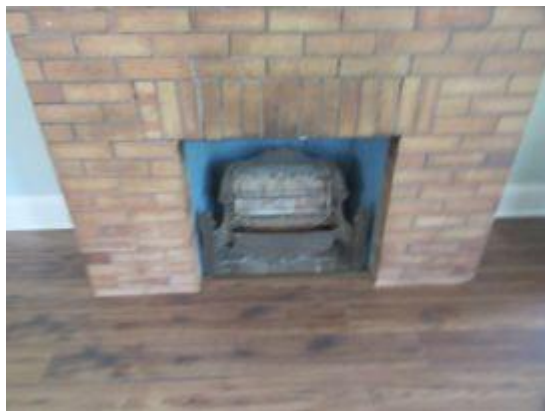
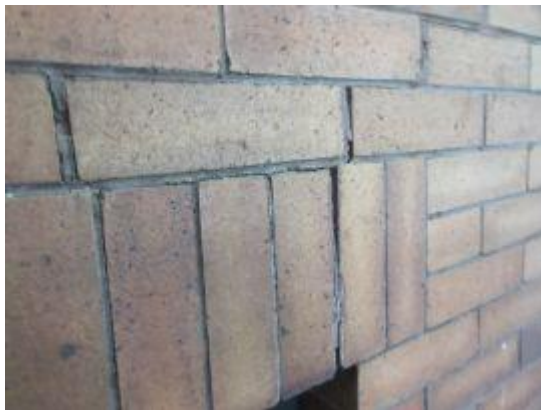
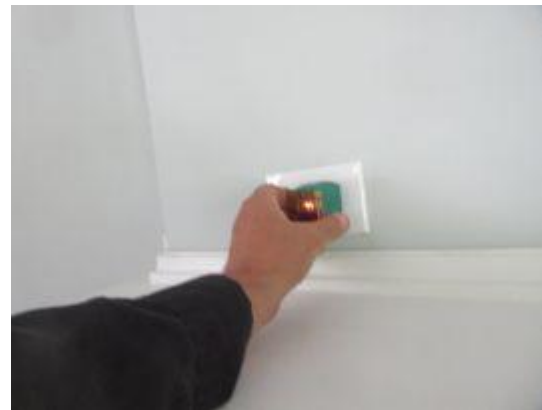
~Fireplace. The fireplace appears to be an old style gas fireplace with ceramic inserts. The gas line is still connected; it should be disconnected and capped. There is some cracking of the masonry work. There are 2 receptacles above the mantel. They are 3 prong and not grounded.

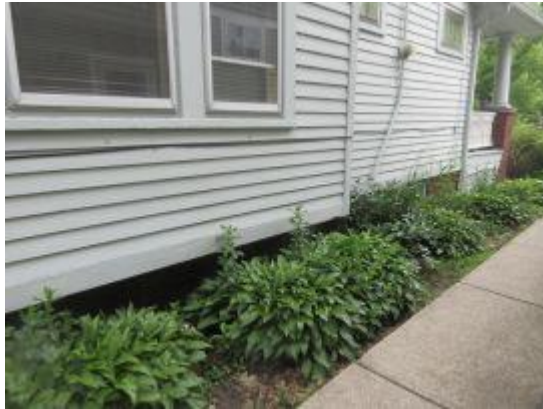
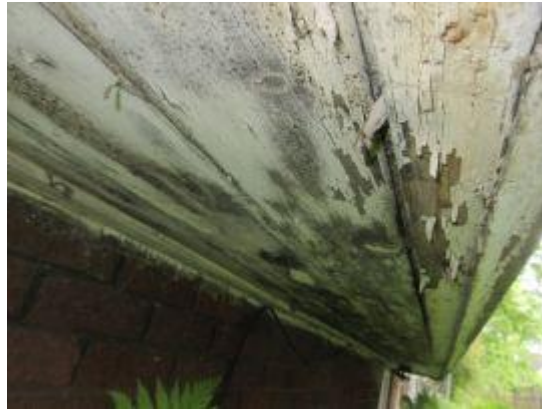
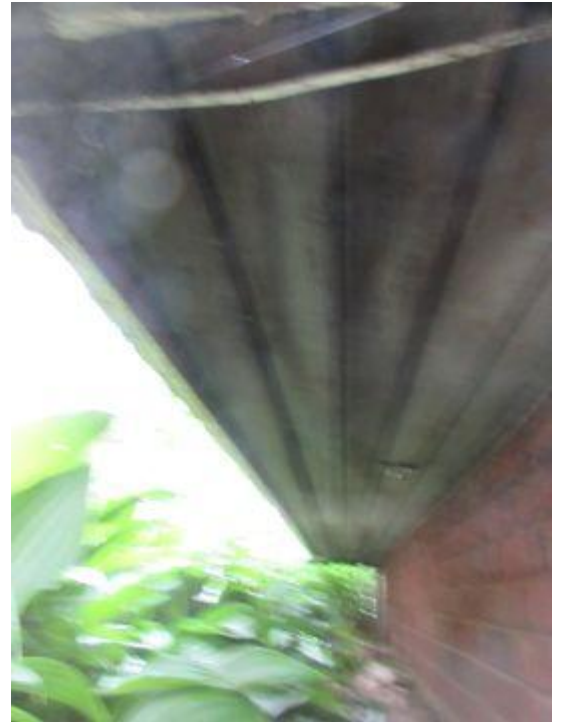
Exterior. Both dining room window seats have planking below. Likely they leak air and can allow insects and small rodents in.

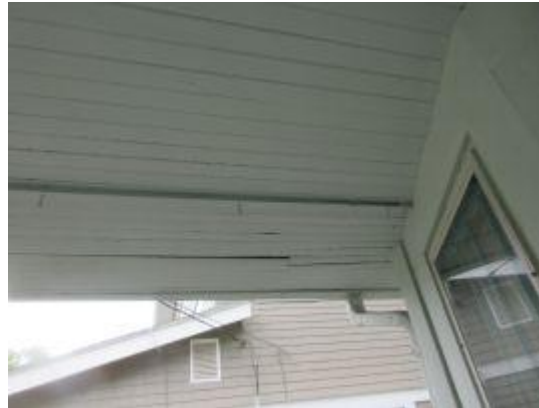
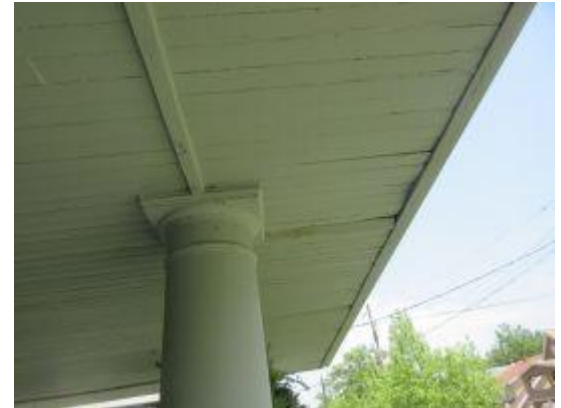
~The sidewalk in front of the steps has settled, creating a higher than acceptable step.

~ The step heights are not consistent.

The top step is very weathered sandstone and may be considered a trip hazard.

The porch ceiling shows signs of past leakage.

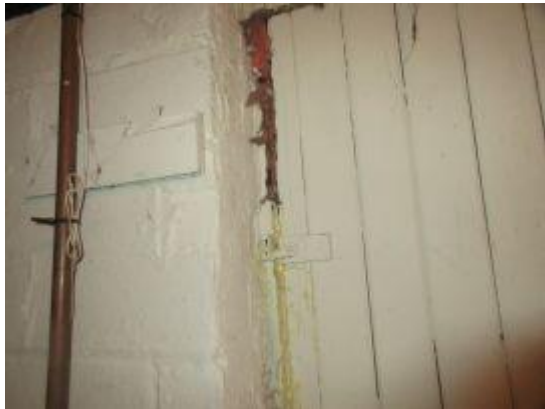
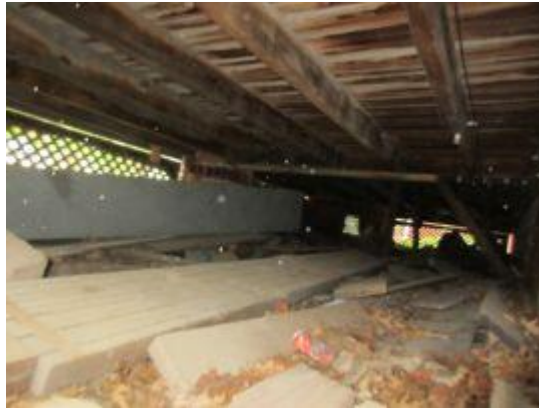
Front Steps & porch. The area below the front porch is difficult to access. The lattice work is not hinged. There are hatches from the basements. However they are sealed. There appears to be much debris under the porches and I could not observe the structures.

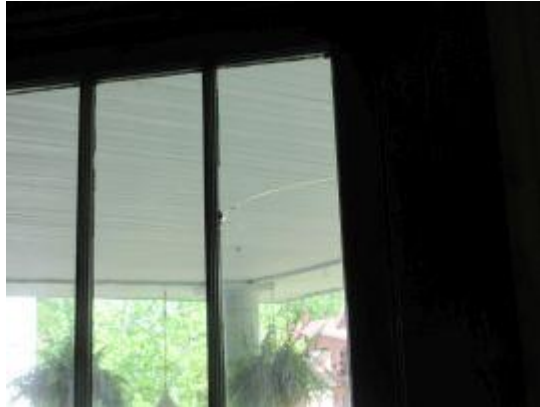
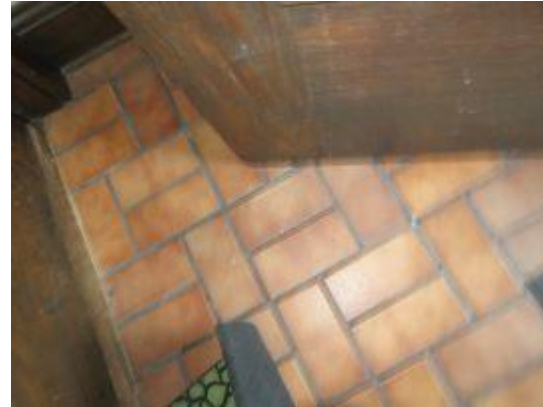
Vestibule. The window is cracked and the bottom of the door needs to be trimmed to properly close.

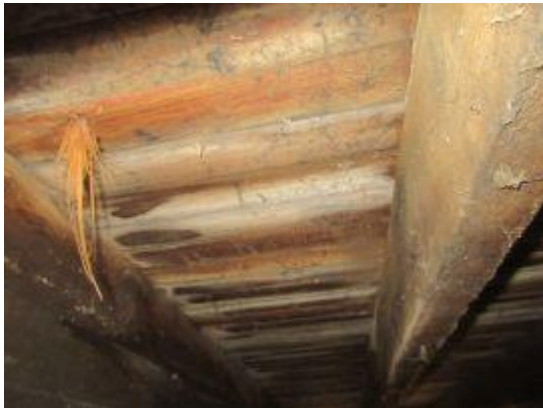
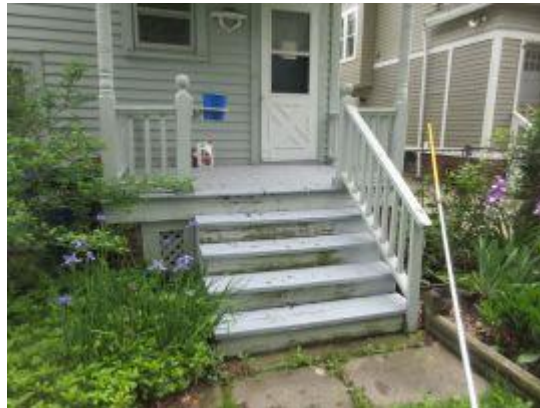
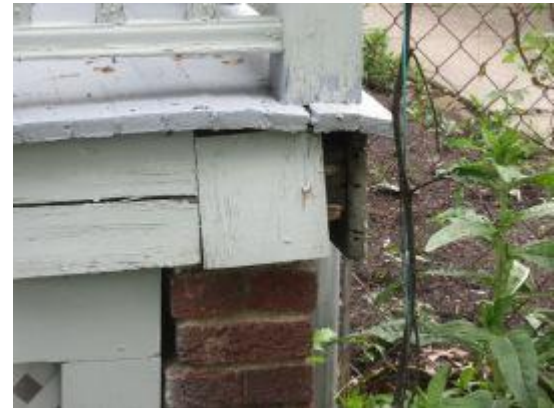
- ~Rear Steps & porch/deck. Like many Northern Ohio Rear steps, these are not built or maintained to current standards.
 - ~ The step heights are not consistent.
 - ~The steps are not high enough to require a handrail.
 - ~The rail needs remounting or bracing to achieve the minimum strength standard.
 - ~The bollards have open spacing more than 4" wide.
- There is some deterioration on the south west corner support
Access below is limited though it seems mostly intact.

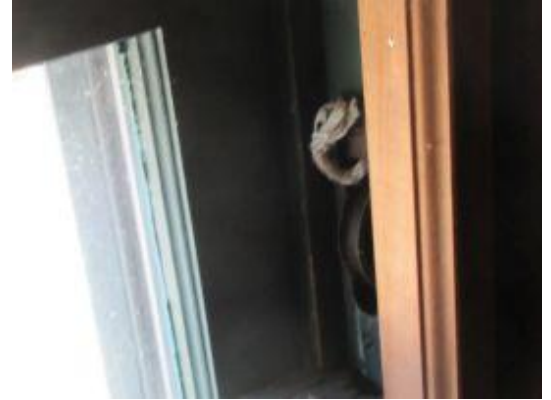
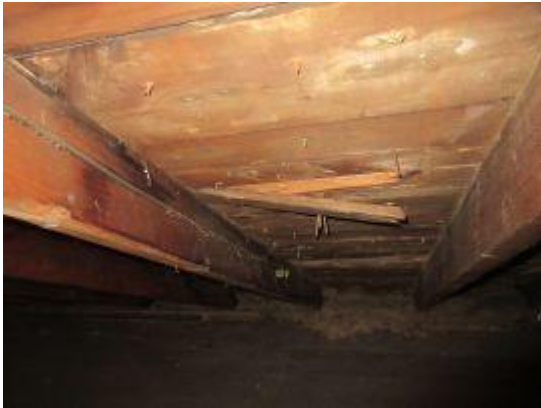
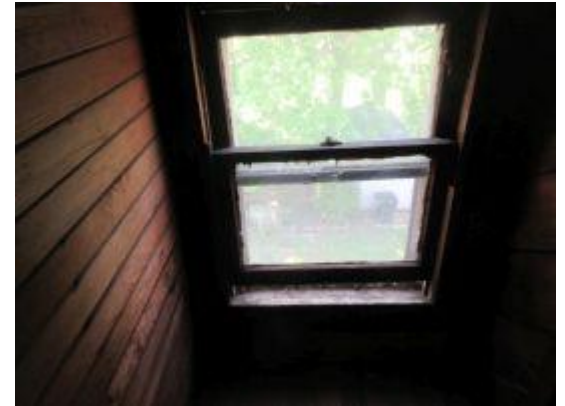
Unfinished Attic. There is some damage to the sheathing from past roof leaks. By today's standard the wall between suites would need to be of fire material and at least smoke taped. It is one sided wood plank and not smoke sealed. The only attic ventilation are the windows that mostly lack sash cords.

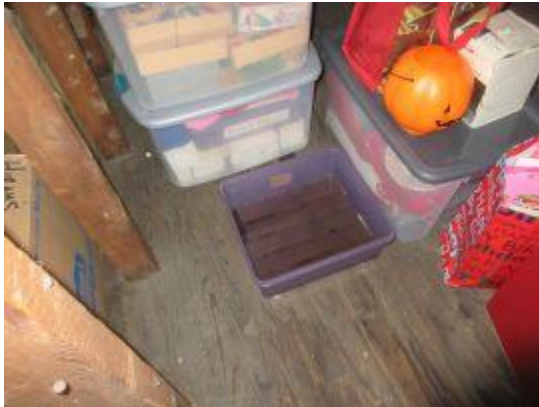
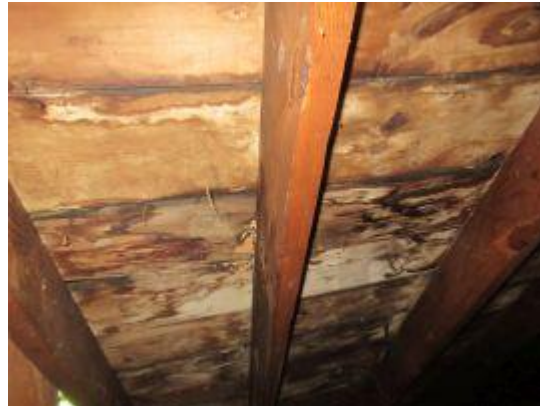
Attic. There appears to be leakage and water caught in a pan. Please see roofing section.

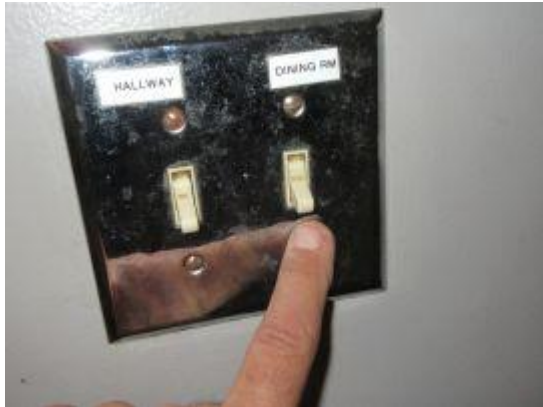
Second floor. The switch in the hall controls the dining room light on the first floor.

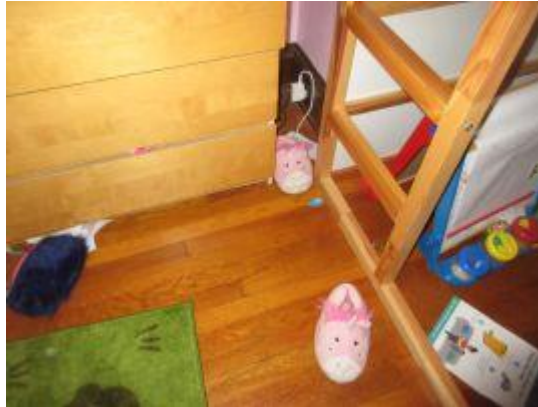
Bedroom center The floor board under the dresser is loose.

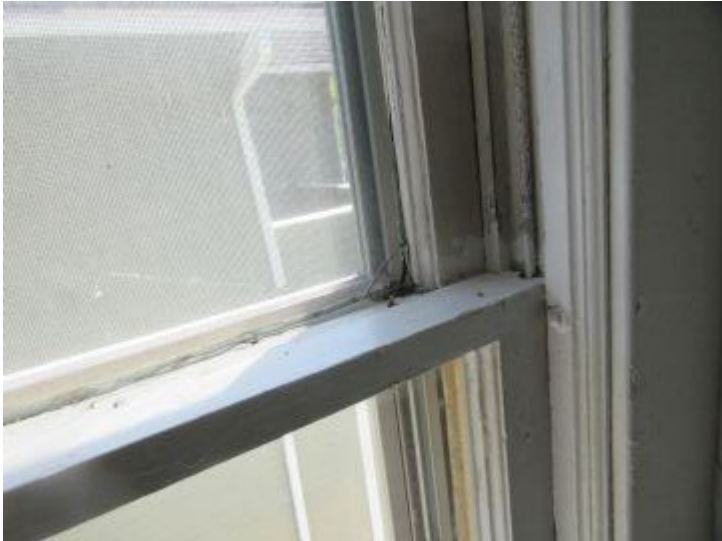
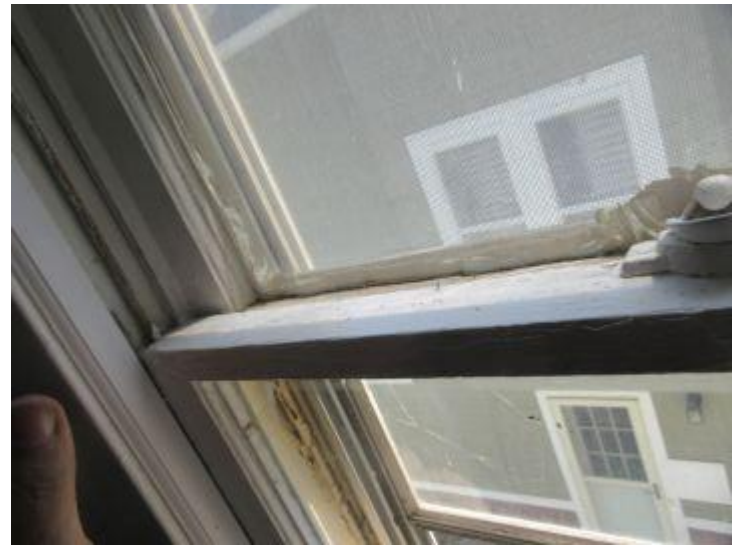
Bedroom. Many of the windows are painted shut. Most need some sash cord replacement.

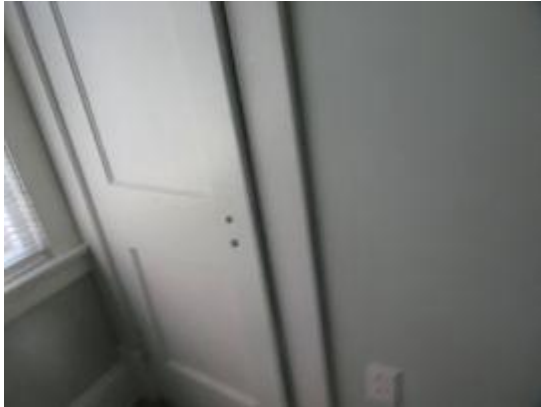
Center bedroom. The closet is missing its handles and latch system.

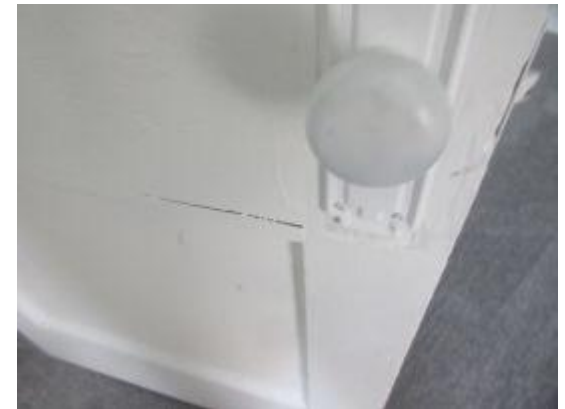
Center bedroom. The door appears to have been broken and poorly repaired.

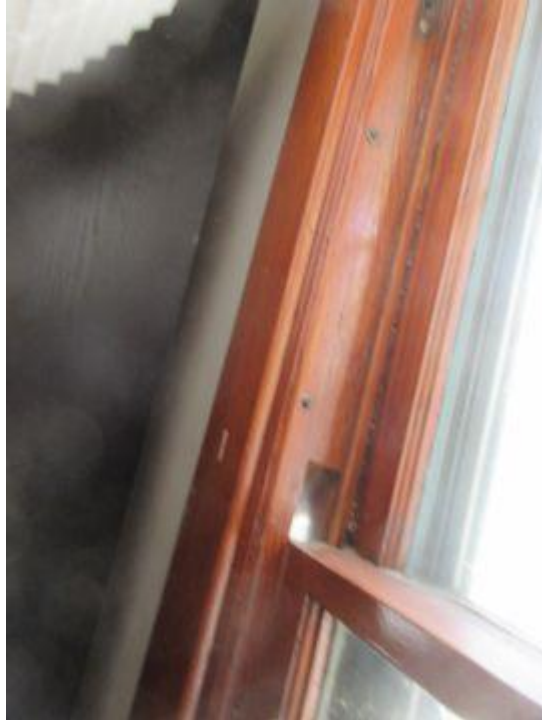
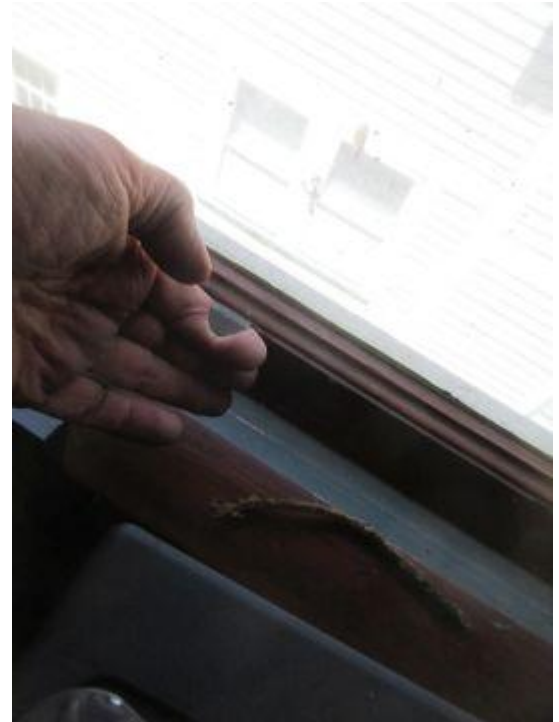
Windows. Many of the windows will not fully operate. Some have spring clips in place of sash cord and most are missing some sash cords. Many have upper sashes that will not open.

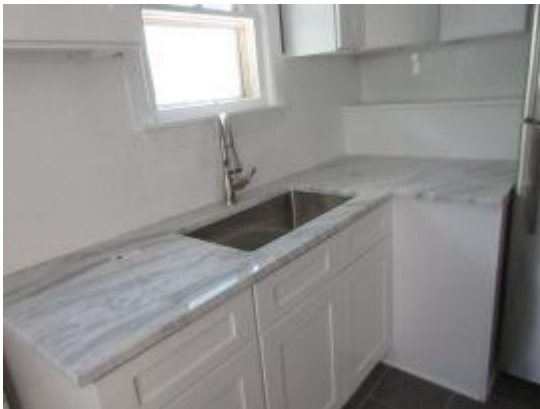
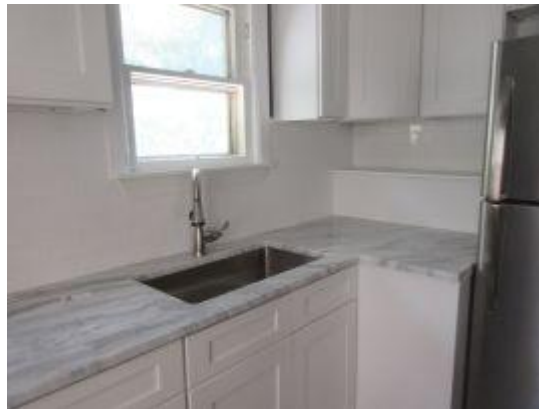
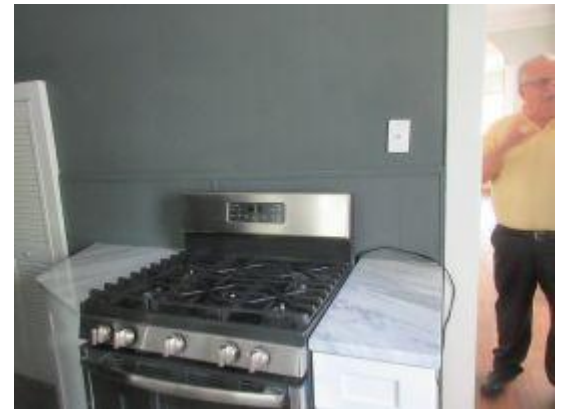
Kitchen. There are no counter top receptacles in the kitchen. Since the kitchen is newly remodeled it should follow current guidelines. For receptacle layout as shown above. All should be GFCI protected the stove too needs a receptacle The stove and the refrigerator need to be assembled. Since they were not assembled they could not be observed working.

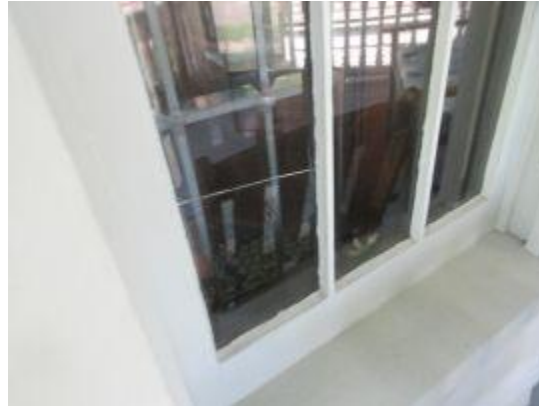
Living Room. The storm window is cracked and appears to be painted shut.

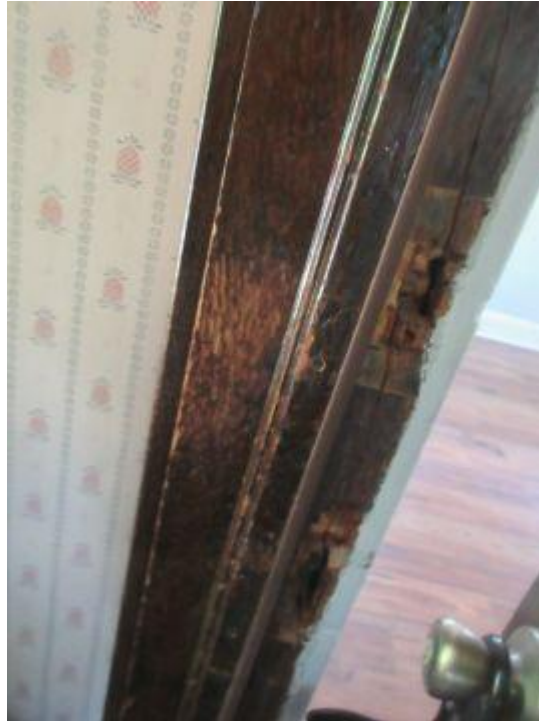
Living Room 1236. On the front door the dead bolt is inoperable and both latch plates are missing.

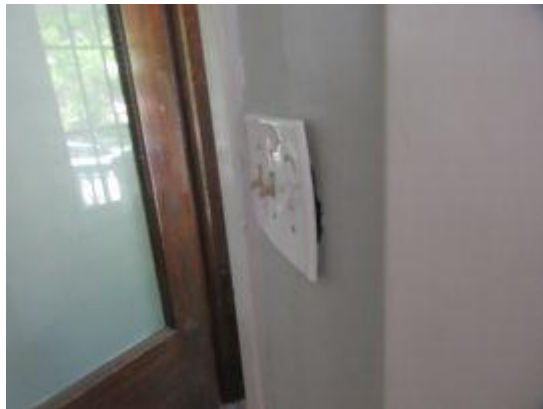
Living Room. The switch box is not properly anchored and is pulling out of the wall.

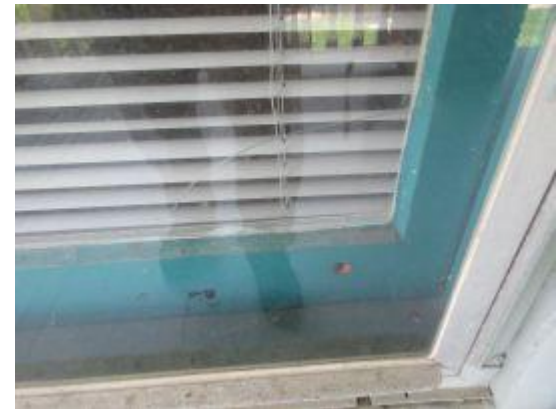
Living Room. The front storm window is cracked.

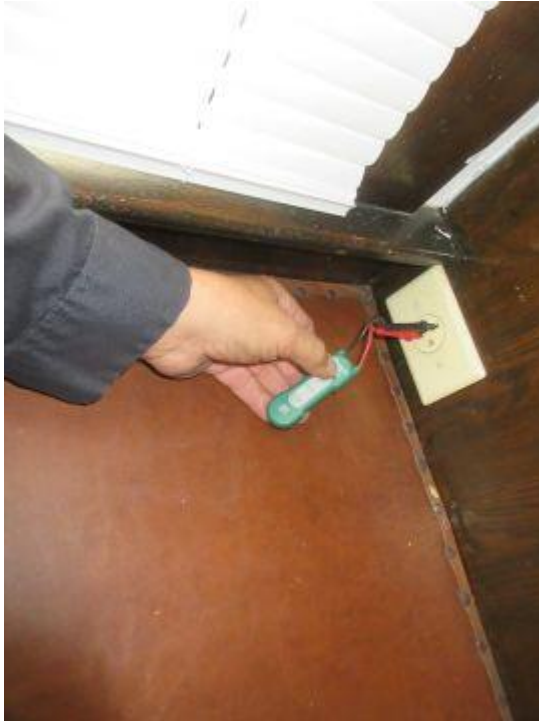
Dining Room. There is a 220 volt outlet, likely for a window air conditioner. It was not energised.

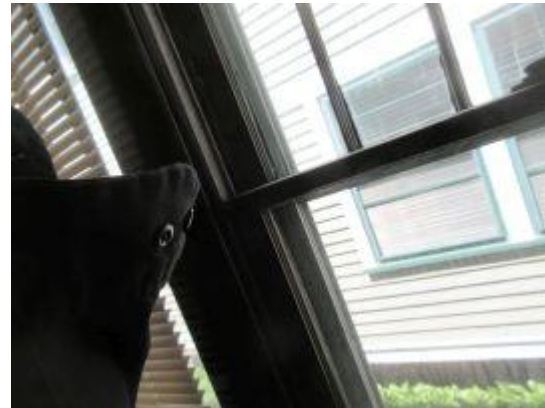
Dining Room. Many of the windows in the dining room and the home have upper sashes that will not open and are missing sash cords.

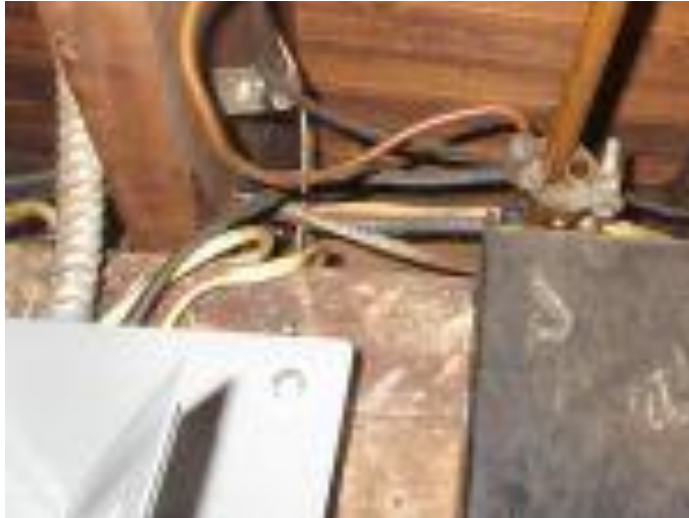
Electrical. The water line connection for the 1234 electrical system is made near the panel with a oversized improper clamp. By new standards, the connection would need to be made as close to the point where the water line enters the building with a proper size clamp. I did not note the connection in 1236. By today's standard it too would have been brought into 1234 near the point of entry.

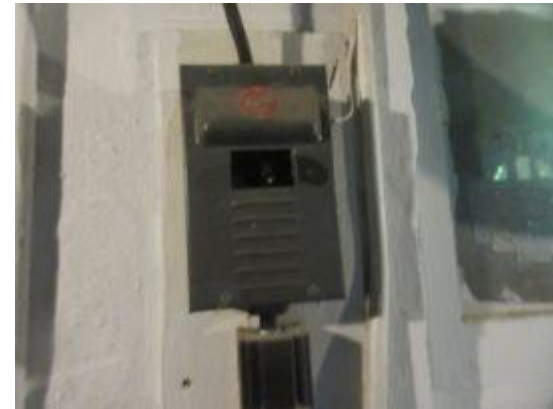
Electrical 1236. Near the laundry area there is a old breaker box being used as a junction box. The opening should be closed with a breaker blank.

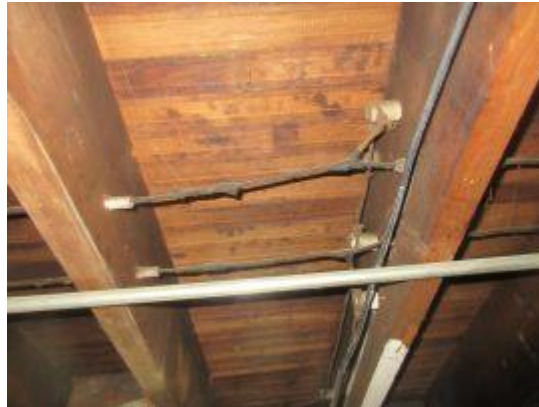
Electrical 1234. There is a lamp holder that is broken and needs replacement. Heat and amperage is the enemy of all older wiring. I recommend the replacement of any incandescent lamps with LED or compact fluorescent to greatly reduce both heat and load.

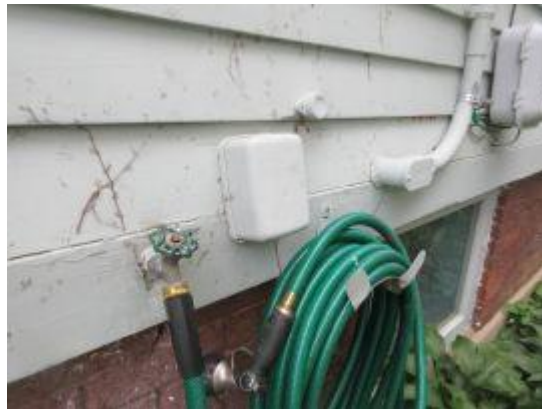
Plumbing. The outside hose spigots are not frost free type and so they should be turned off and drained for the winter.

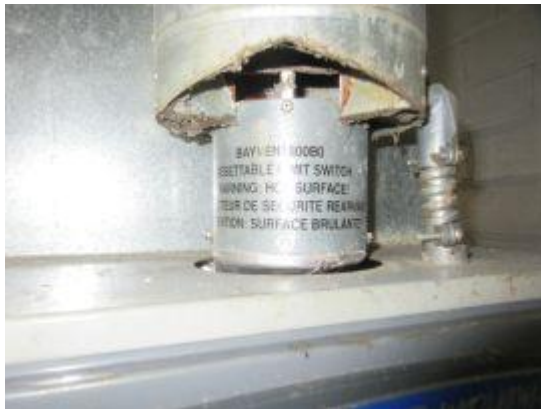
Heating. The furnaces are in need of a good cleaning and likely have not received their yearly service.

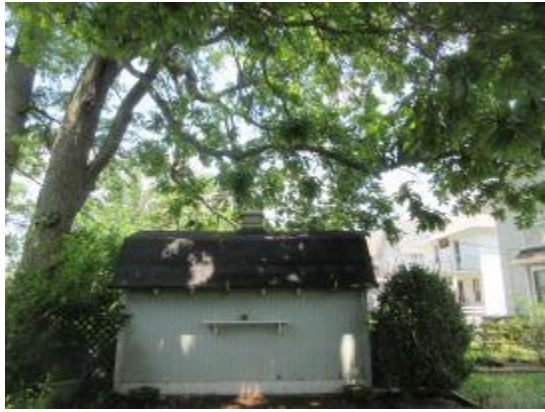
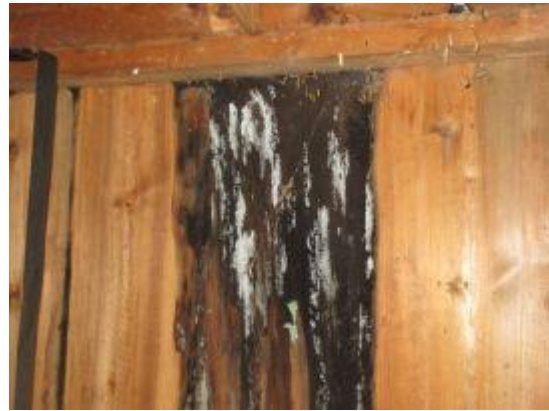
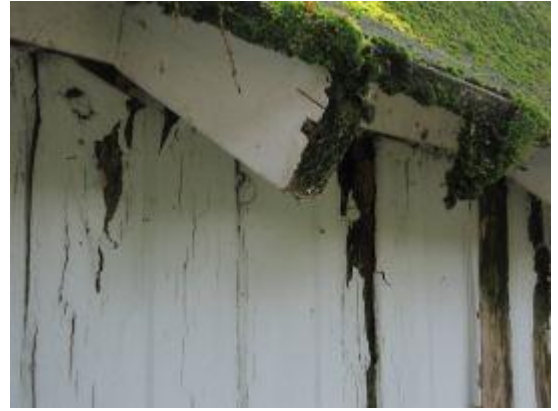
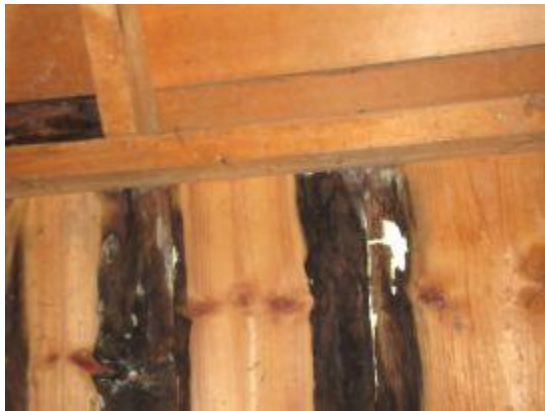
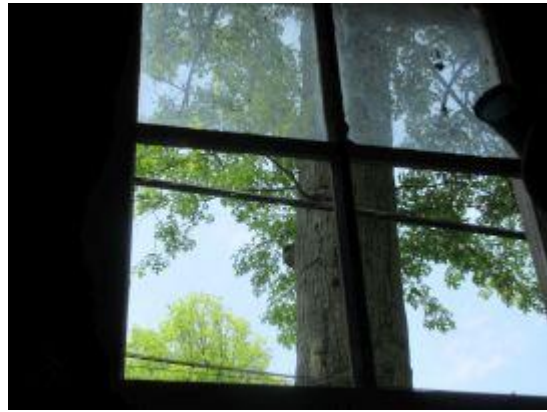
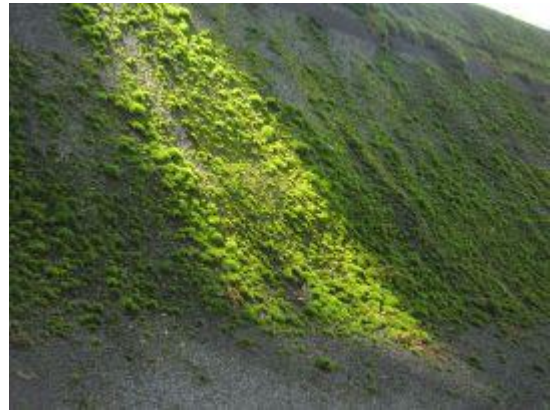
Shed. The shed needs some TLC. The coupla is decaying and leaking. The roof needs replacement It is heavily moss covered and leaking. The siding is pine and decaying . The window is missing glass and allows birds in. May I suggest covering both walls and roof with metal roofing. If city accepts it would be a durable inexpensive solution. And comes in many colors
