● Statistics 1

Ohio Home Inspectors LLC.

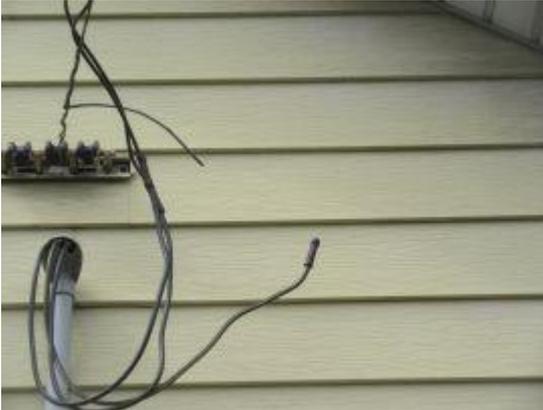
Electrical. The neutral/ground at the service attachment is disconnected and needs to be repaired.

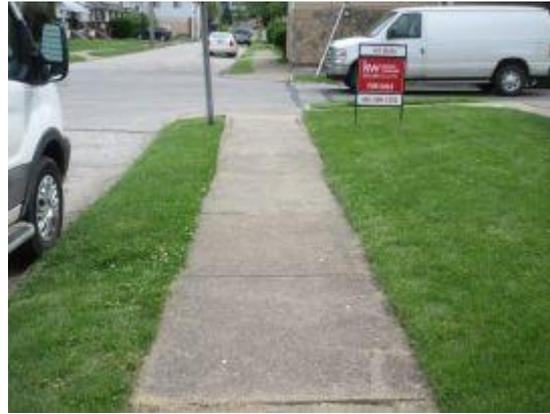
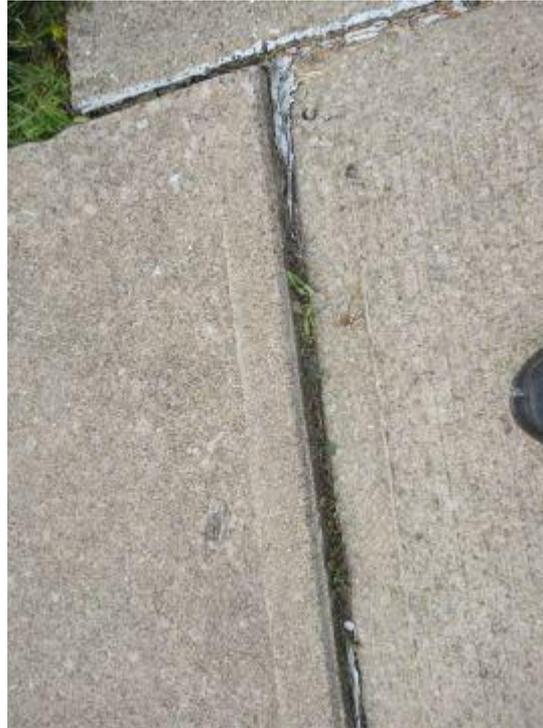
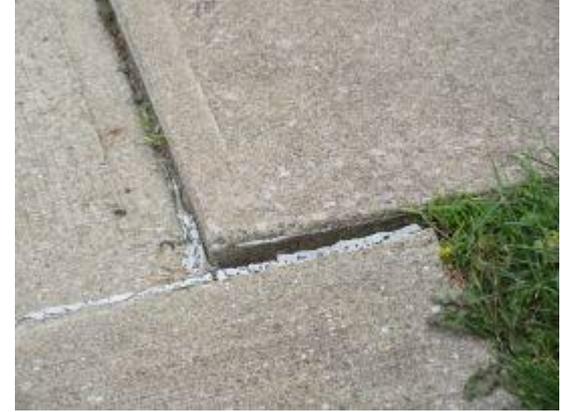
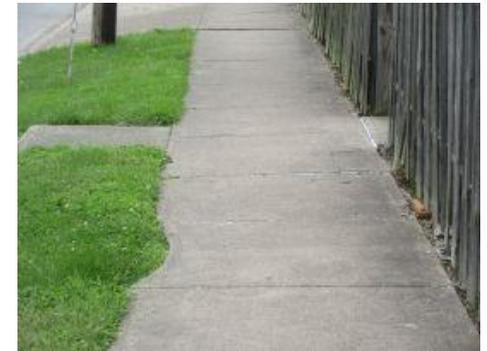
~Site. The public sidewalk has experienced some shifting that may be considered a trip hazard. This appears to have been from past trees and the effect of their roots.

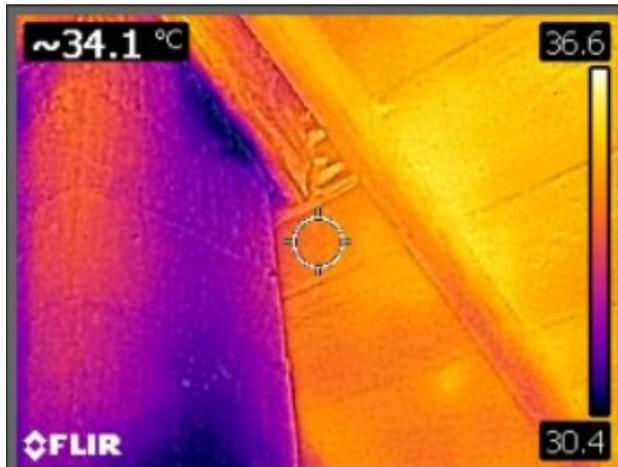
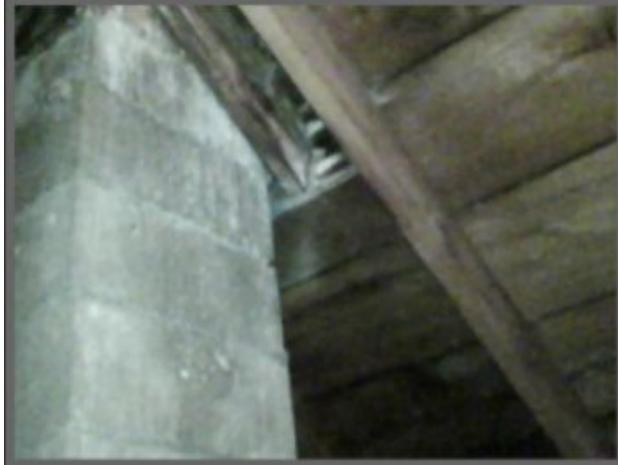
Roofing. Though the conditions may not be the best for reliable thermal imaging. The area near the chimney that had water marks shows no signs of evaporating water.

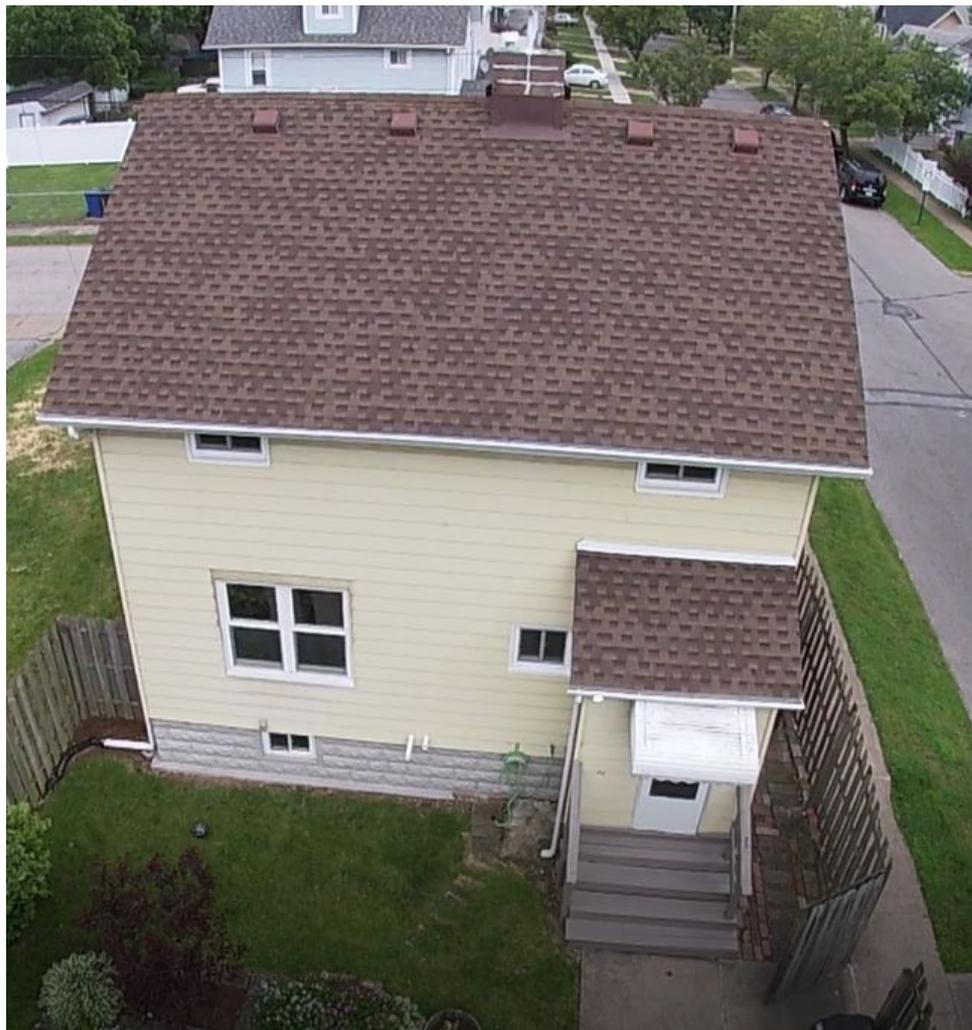
~Chimney. The chimney has no crown. It should have a stone or concrete one with an overhang and drip edge that should keep the upper bricks dry. Another area of concern is chimney flashing. Often times, the area around chimney will have water marks from past leakage. Flashing leaks can be dependent of wind direction, snow build up or volume of rain. So it is likely that the leak may not occur at time of inspection. The only way to know for sure is to engage a roofer. He will need permission to install safety gear from the homeowner. (beyond the scope of a ASHI inspection)

The chimney appears to have no ceramic flue liner. It also appears to have abnormally small joints.

~Some evidence of masonry pointing or rehabilitation has been observed.

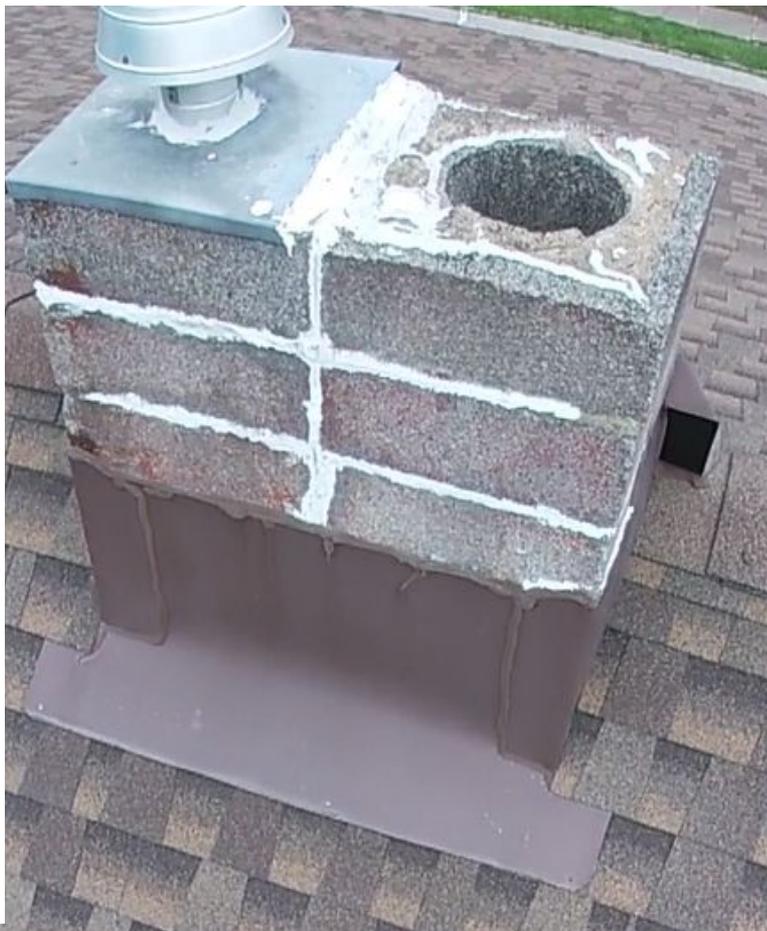
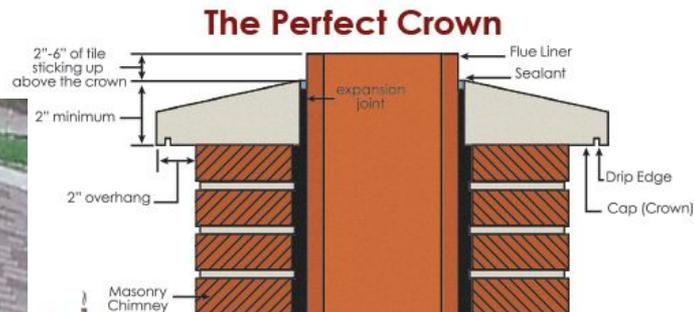
Chimney. It appears that a metal flue liner had been added for the hot water tank.

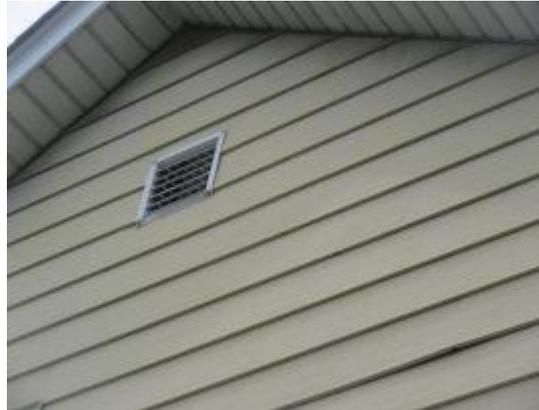
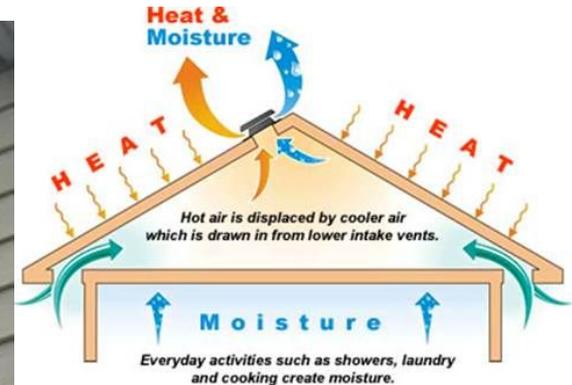
Insulation/attic ventilation. The ventilation would be considered less than adequate.

- ~For upper ventilation there are static vents.
- ~For upper ventilation there are gable vents.

- ~~Effectively there is no lower ventilation.
- ~With no lower venting, the natural flow of air from low to high will not be created.
- ~The two main reasons we vent the attic is to remove moisture from the home and to cool the roof.
- ~Many older homes are deficient in ventilation. It was not required and builders did not concern themselves.

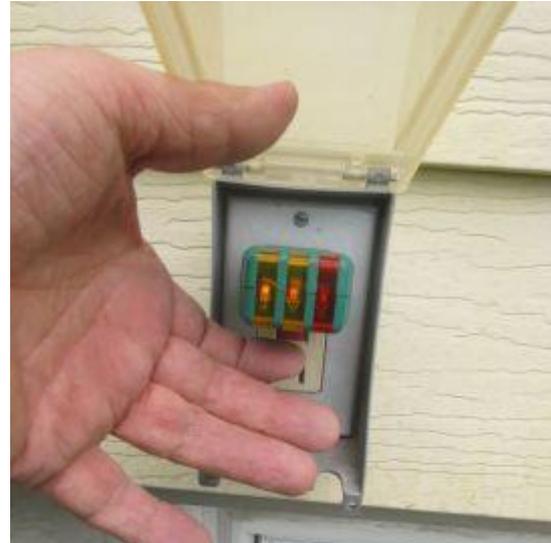
Exterior front receptacle.
Is GFCI protected
However the GFCI will not
trip and needs to be
replaced

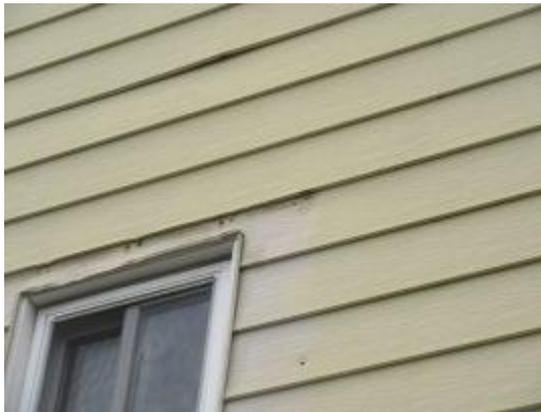
Exterior. As is typical for homes that are even a few years old there is minor damage on the siding.

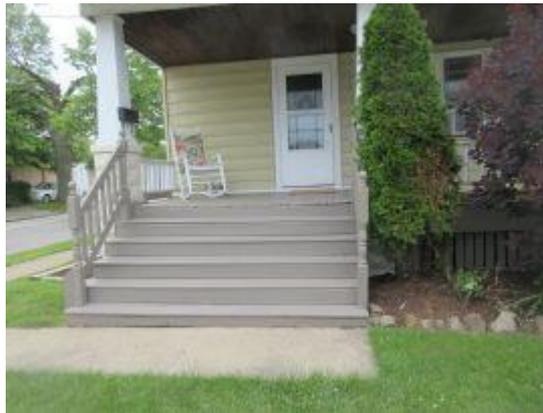
- ~Front Steps & porch/deck. Like many Northern Ohio front steps and porches, these are not built or maintained to current standards.
- ~The sidewalk in front of the steps has shifted , creating a lower than acceptable step.
- ~ The step heights are not consistent.
- ~The handrail is not considered graspable.

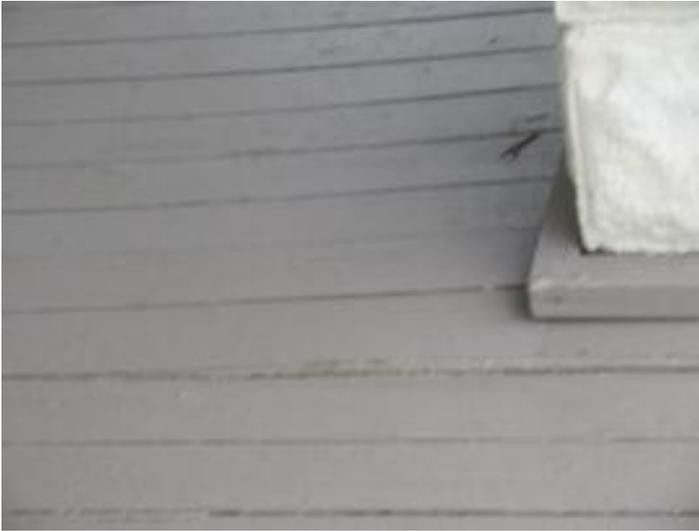
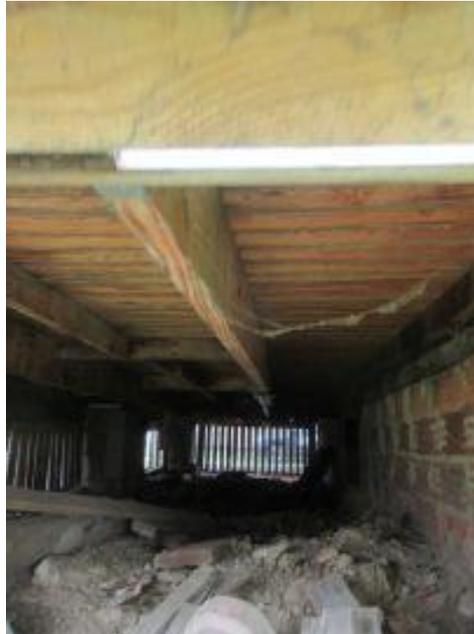
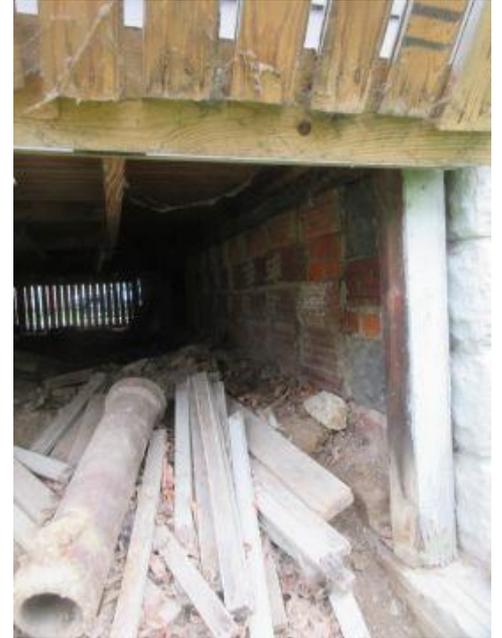
Front porch. It appears that the front porch has been repaired. Much debris in left below the porch. Also there is some unevenness on the porch floor.

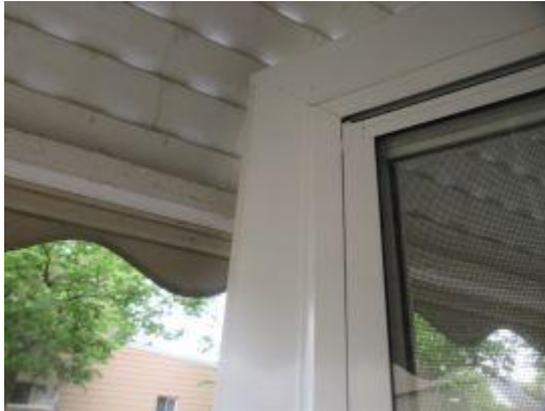
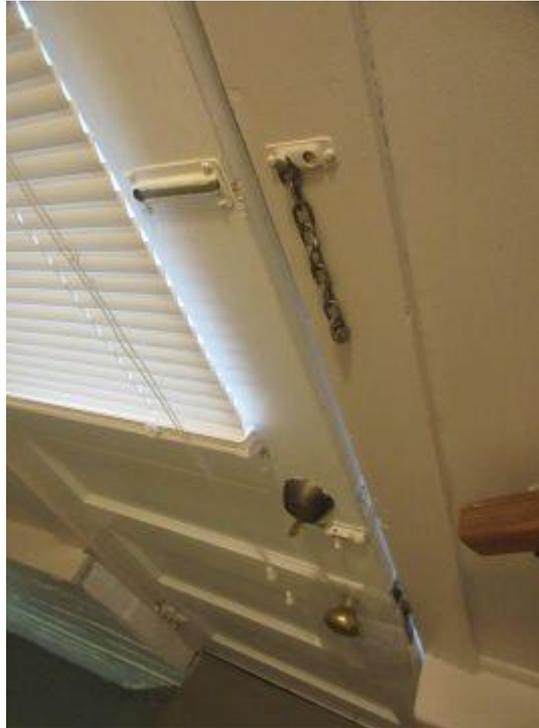
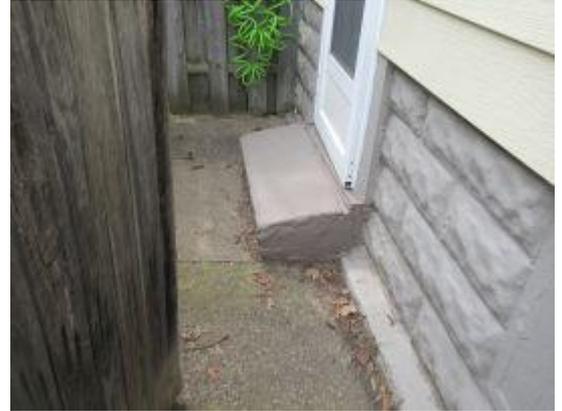
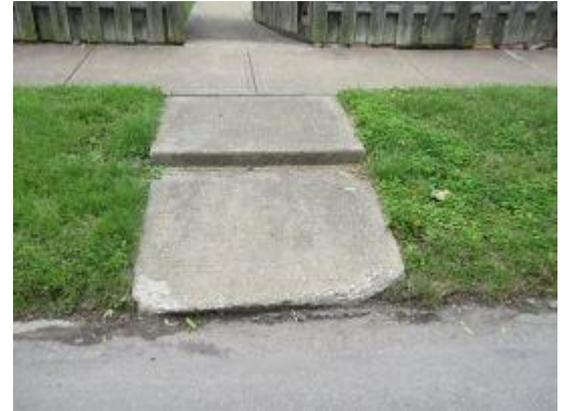
Side door.. The door has a double keyed deadbolt. This is no longer permitted in Ohio in residents. Until it can be changed a key should be left in it whenever anyone is home.

Side entry. Both the step by the door and the ones by the street are uneven and can be considered a trip hazard.

Side entry. The storm door hits the awning.

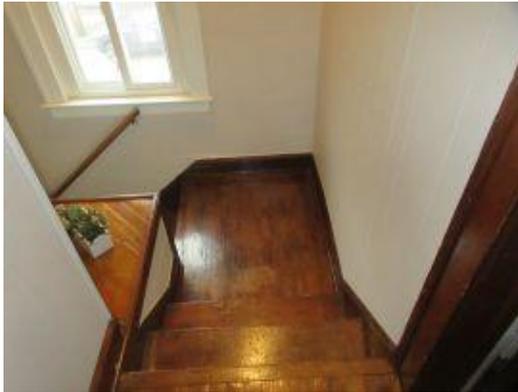
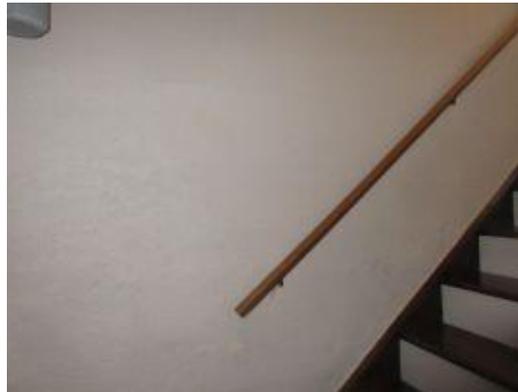
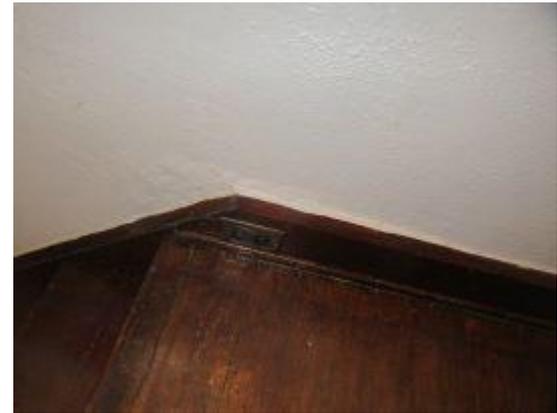
~The steps are steeper than current standards would allow.

~The handrail does not return to the wall creating a clothing snag issue. The upper portion of the step has no handrail.

~~The window in the stairwell is not safety glass.

The plaster work on the wall appears to have been damaged and is not fully professionally repaired.

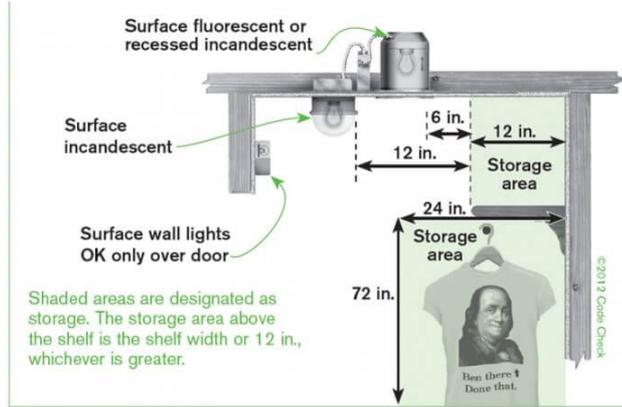
~~Bedroom. Incandescent surface mounted fixtures are not to be used in clothes closets. With the current use of LED light bulbs, many building departments are

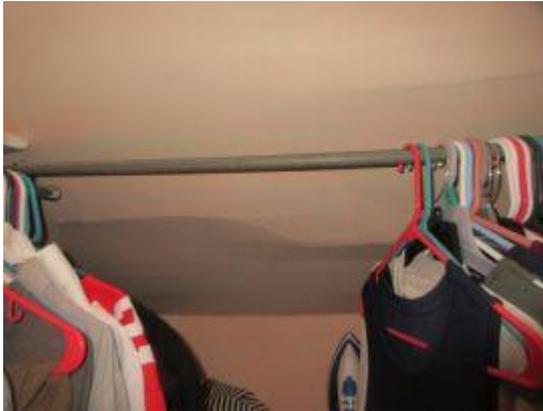
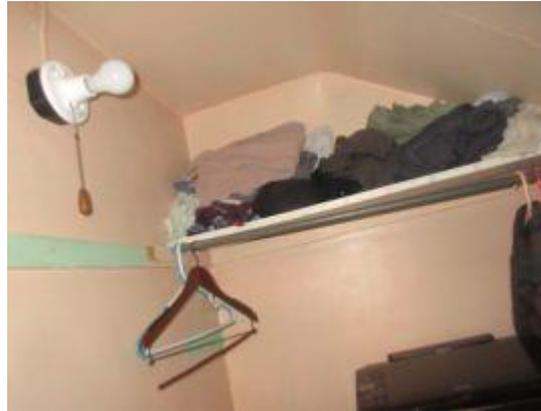
Master Bedroom. The plaster work in the closet appears to be loose.

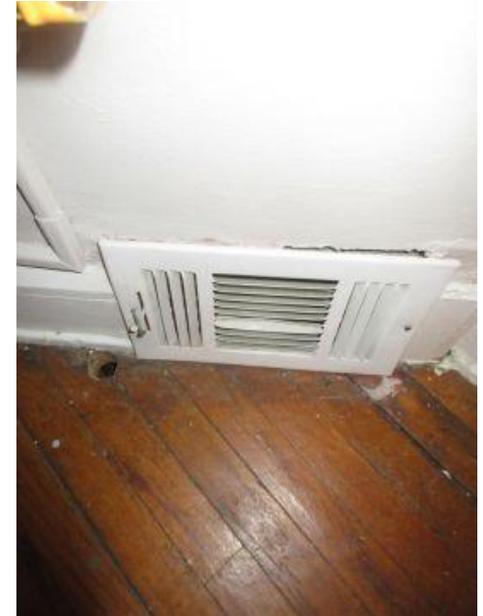
Master Bedroom. This is the damper that is added and mentioned as it passes through the living room closet. It is non professionally installed.

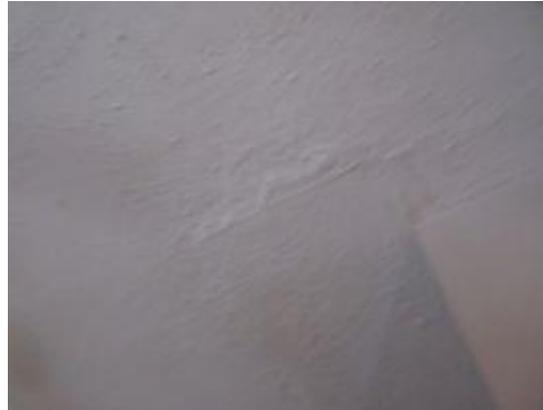
Bedroom. The ceiling of the south west bedroom in particular have some non professional repairs.

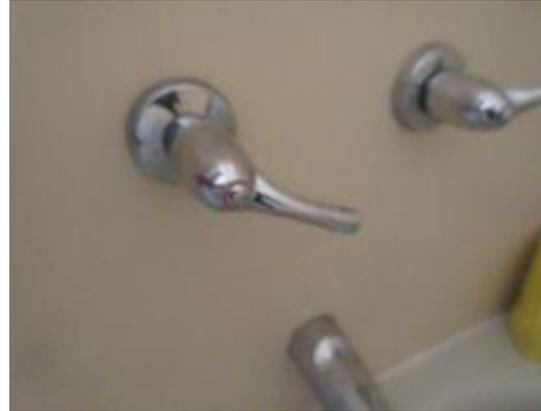
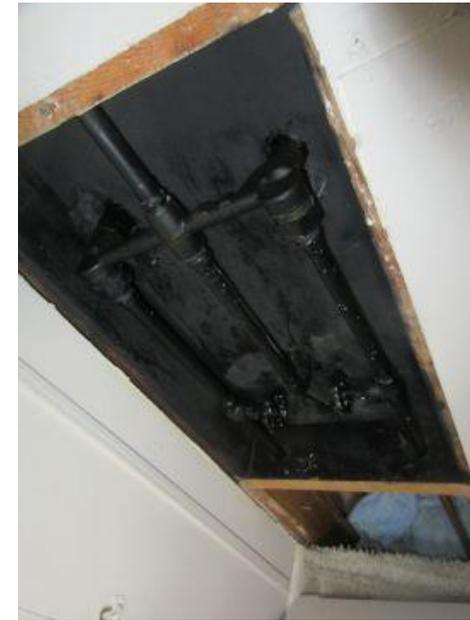
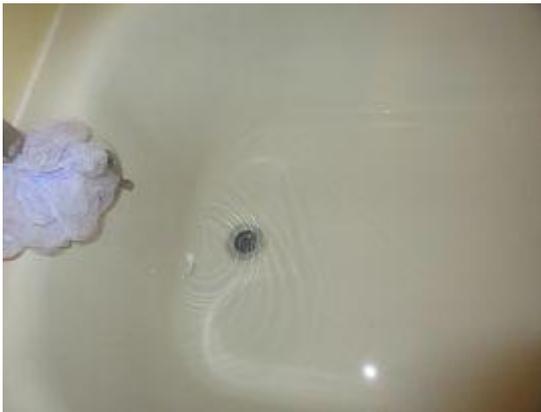
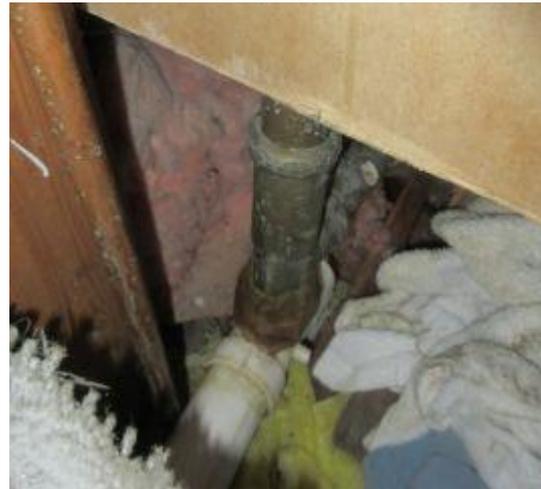
Bathroom Second floor. The tub drain is slow. Likely a hair clog. It too can be that there is steel drain pipe in the walls which rusts from the interior out and tends to clog. There appears to be putty on the drain pipe and many towels pushed in to surround it. The towels felt moist. The hot water valve had no stop; you can rotate it around and around. The tub surrounding the pipe has been painted black. Perhaps to seal the plumbing.

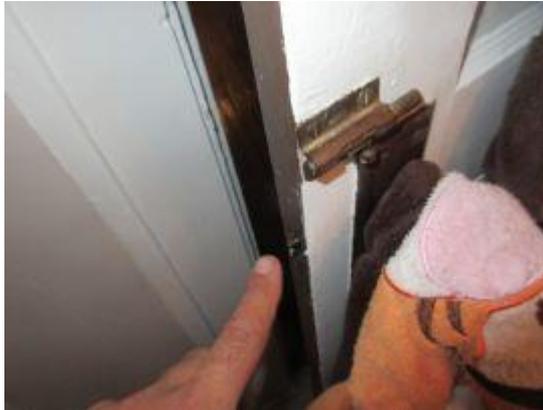
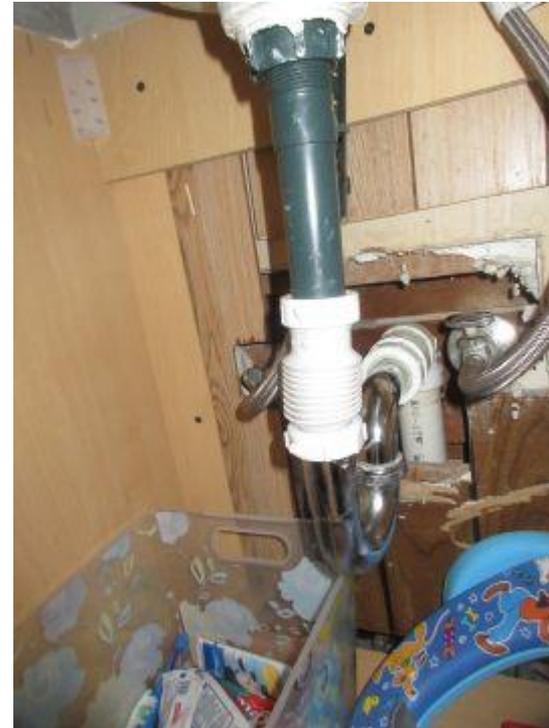
~Bathroom. The drain for the sink is improperly vented. This can lead to siphoning from the water in the trap and may lead to the escape of sewer gas. If this occurs, an air admittance valve can be added. Please see sketch for this application on the first page of the plumbing section.

Bathroom Second floor.
The door latch does not
properly engage.

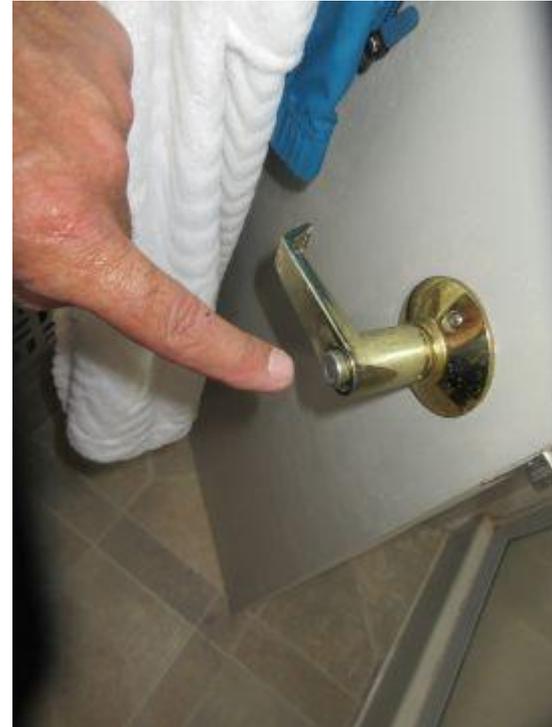
Basement Bathroom. The switches are wrongly installed behind the door.

Basement Bathroom. The lock on the door will not engage.

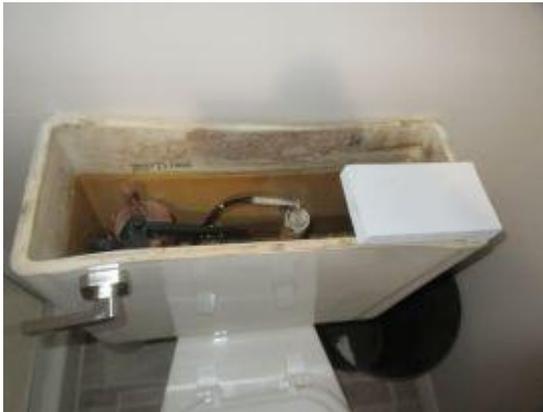
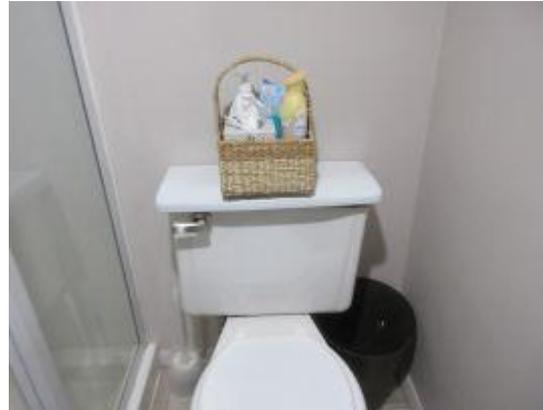
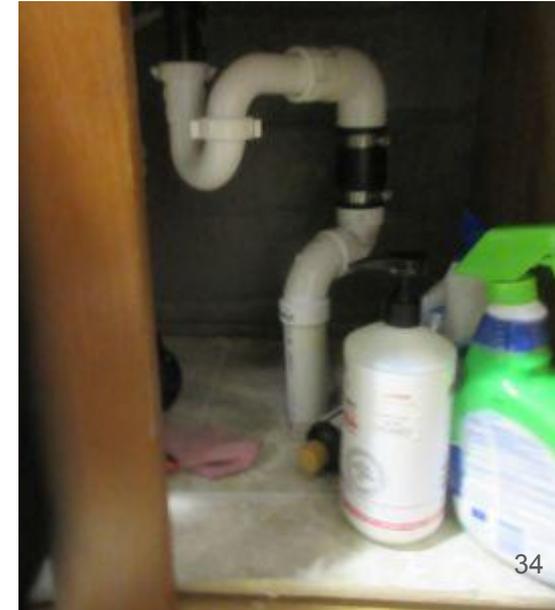
~Bathroom. The drain for the sink is improperly vented. This can lead to siphoning from the water in the trap and may lead to the escape of sewer gas. If this occurs, an air admittance valve can be added. Please see sketch for this application on the first page of the plumbing section.

Basement Bathroom. The toilet lid likely is not made for the toilet. A block of plastic has been installed to level the tank top. It appears that the filler valve sticks.

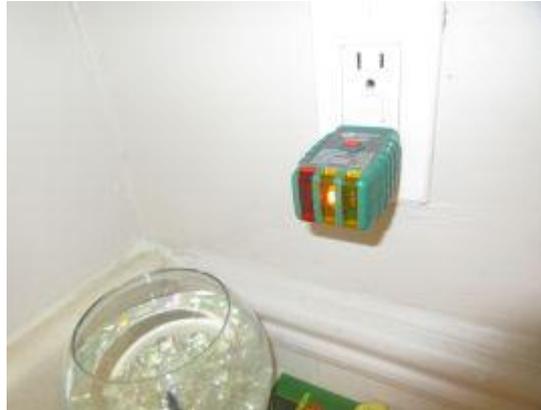
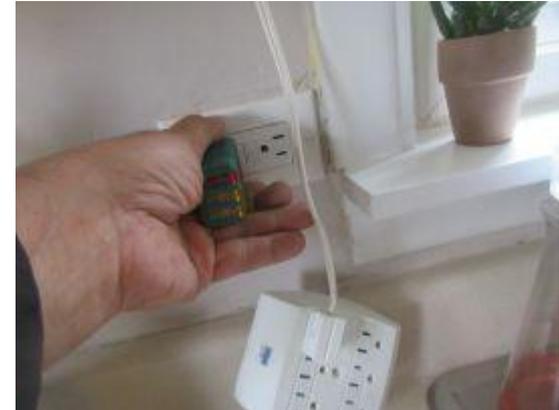
Kitchen. The receptacles near the sink are GFCI protected. They are not grounded. If a GFCI is mechanically working it does not have to be grounded to protect. The cover should be permanently marked "NO EQUIPMENT GROUND"

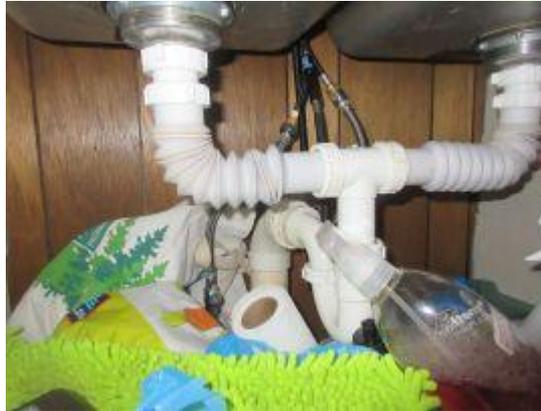
~Kitchen. The drain for the sink is improperly vented. This can lead to siphoning from the water in the trap and may lead to the escape of sewer gas. If this occurs, an air admittance valve can be added. Please see sketch for this application on the first page of the plumbing section. It is not professional to use flexible drain pipes they tend to clog.

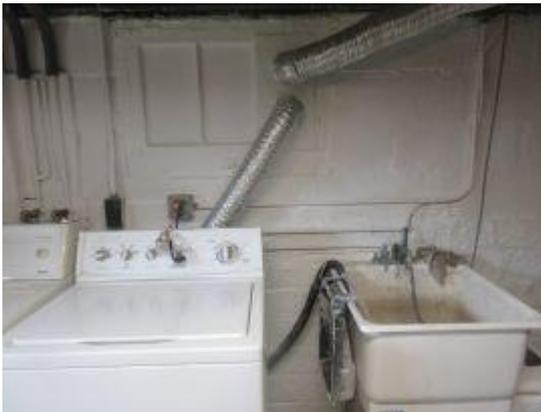
~Laundry. Since the receptacles serving the washing machine is closer than 6 feet from the laundry sink should be GFCI protected. When the home was constructed this was not required.

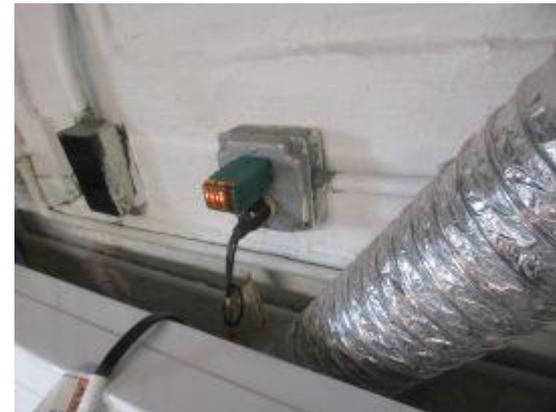
~Laundry.. Since the wash machine is on a finished floor level it is recommended that it has a drain pan with a connected drain.

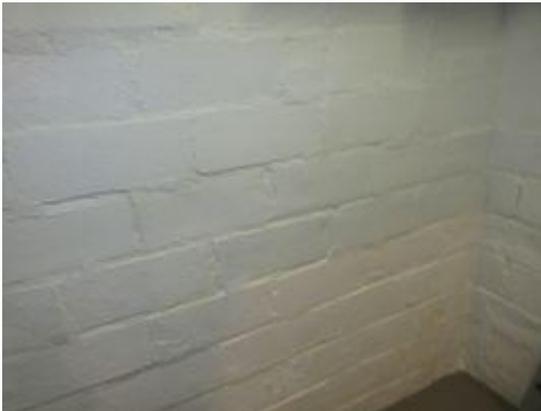
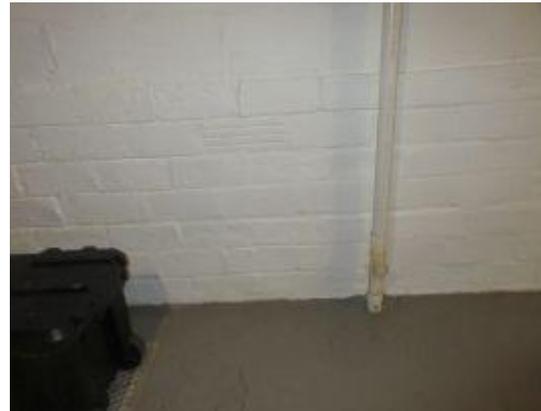
~~Unfinished Basement. There is some foundation cracking. It does not seem severe enough for concern. The walls are painted with a sealing paint. Sealing paints can mask problems. You may make a judgement to bring in other experts. Consult your realtor.

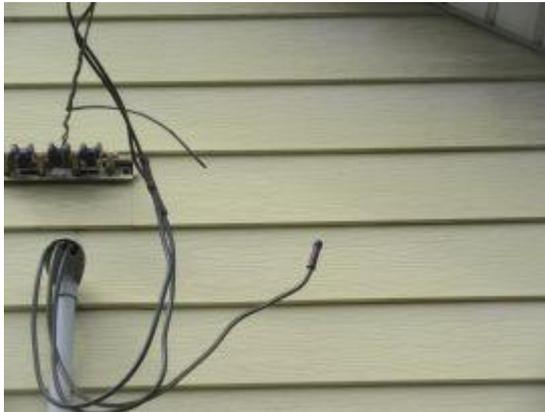
Electrical. The neutral/ground at the service attachment is disconnected and needs to be repaired.

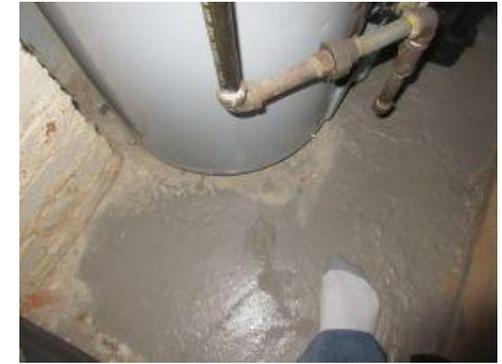
Plumbing. Since the hot water tank is located on a finished floor level a drain pan with the drain connected would be required for today's standard.

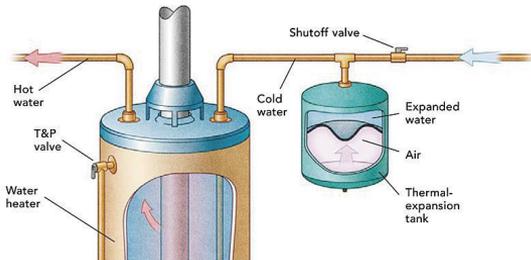
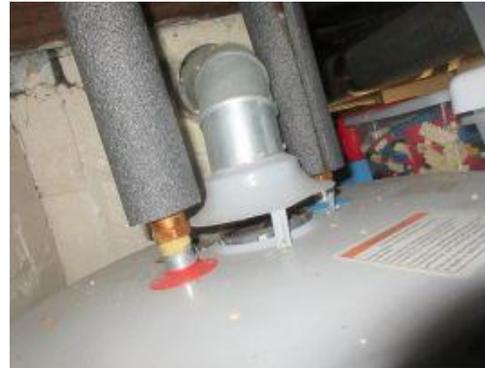
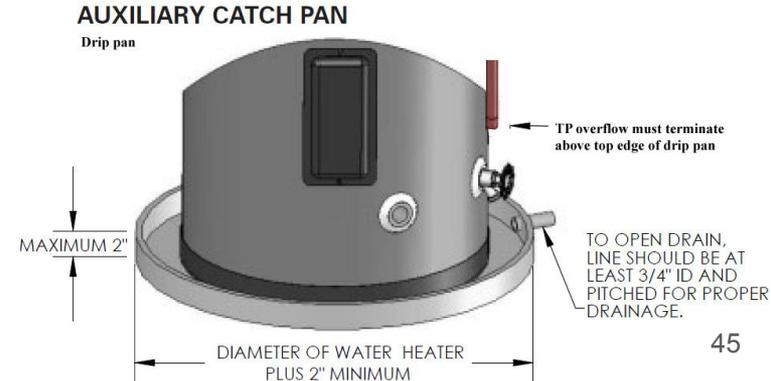
~Plumbing. By today's construction standard, the hot water tank would have an expansion tank. Backflow valves or pressure reducers in the water service restricts dissipation of built up pressure resulting in release of the PTV valve. So installing the expansion tank when tanks are replaced is good practice. This reduces pressure buildup that may result in PTV valve bleed off. Even if no pressure reduction or check valves are installed, many new water meters today have check valves. Creating the same problem.

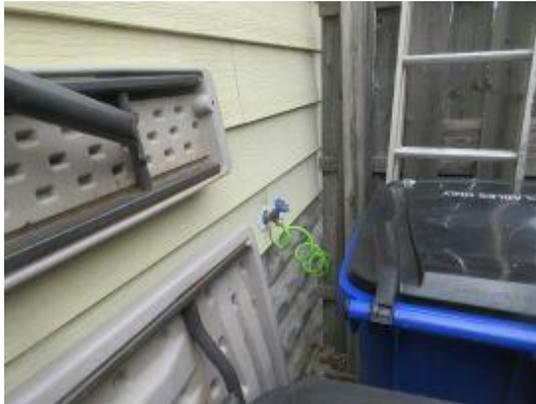
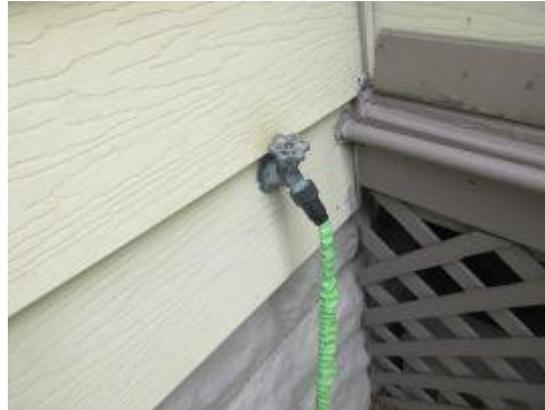
Not frost free

Plumbing. The outside hose spigots are not frost free type and so they should be turned off and drained for the winter.

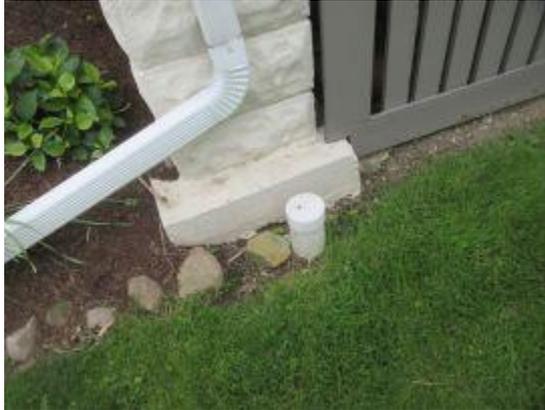
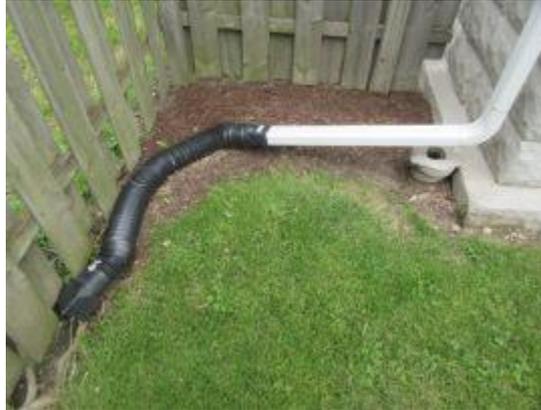
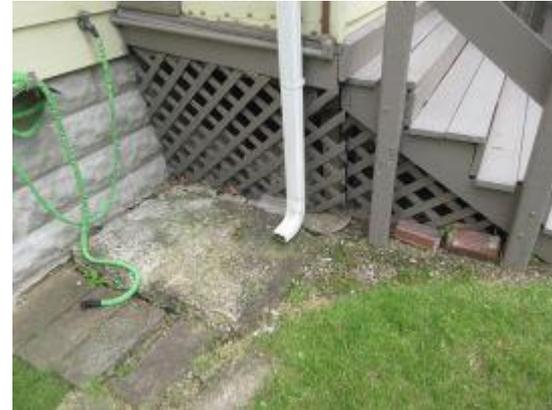
- ~~Likely of this age had below grade clay time downspout terminations.
- ~~It is evident that most of the downspouts have been rerouted above grade.
- ~~This is likely an indication that a basement dampness has occurred.
- ~~Above grade downspout terminations should be routed at least 6 foot from the foundation.
- ~~some below grade downspout terminations are PVC.
- ~~This likely indicates that some effort to control basement dampness has occurred.
- ~~If waterproofing has occurred likely there are warranties.
 - ~~Prior to transfer every effort should be made to receive the names and receipts from any contractor who has worked on the home as well as any warranty information.

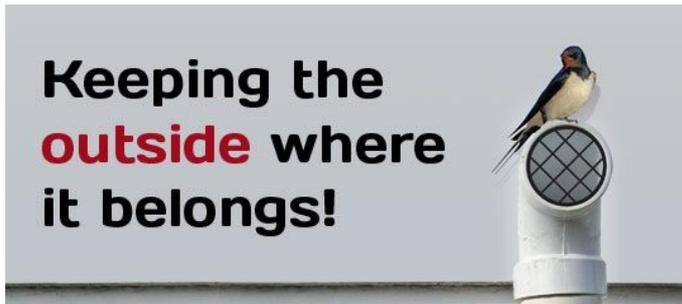
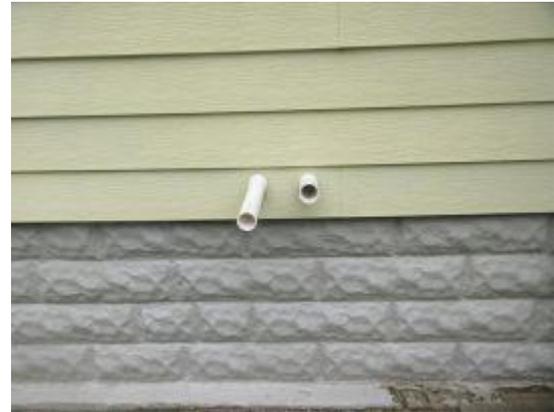
Heating. Most high efficiency appliance manufacturers recommend bird screen on supply and exhaust pvc vents

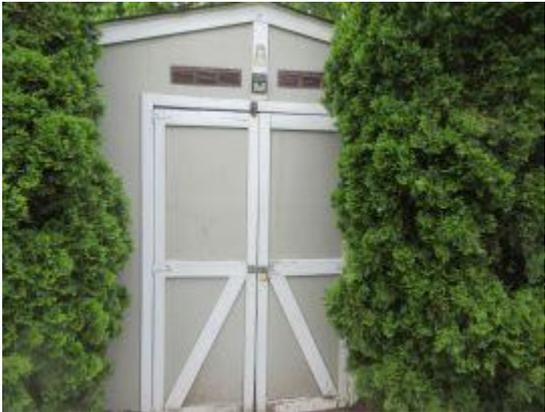
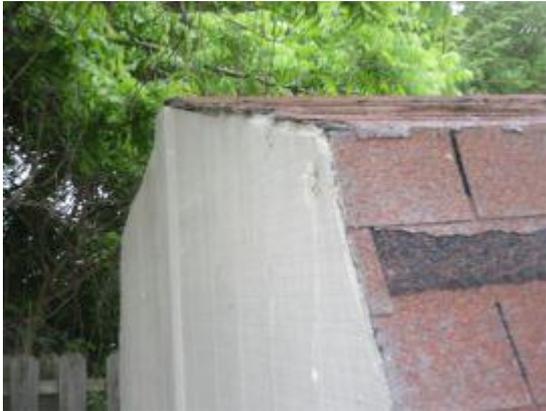
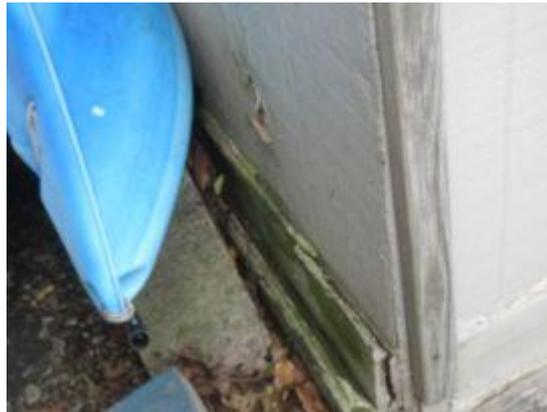
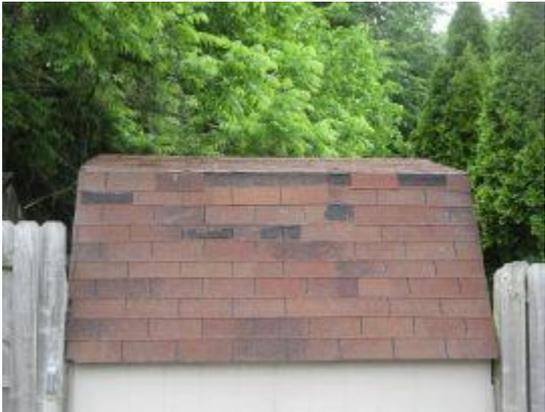
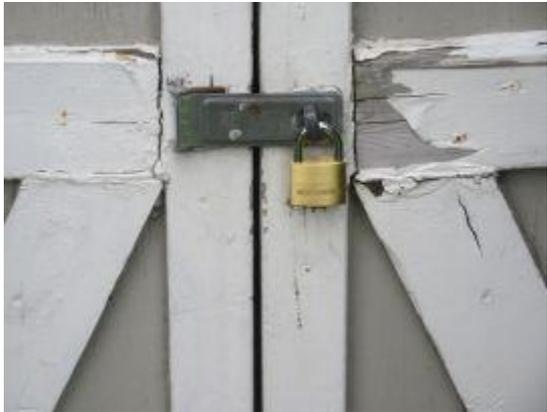
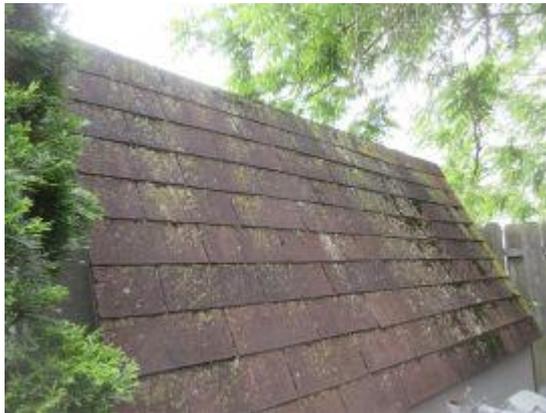
Shed. The shed was locked so I could not fully asses it. The roof appears to need some maintenance and moss removal. The lower portion of T111 siding is deteriorating this is very common.
