XXXXXX 9876

● Statistics 1

Prepared by: Jerry Salontay

Ohio Home Inspectors LLC.

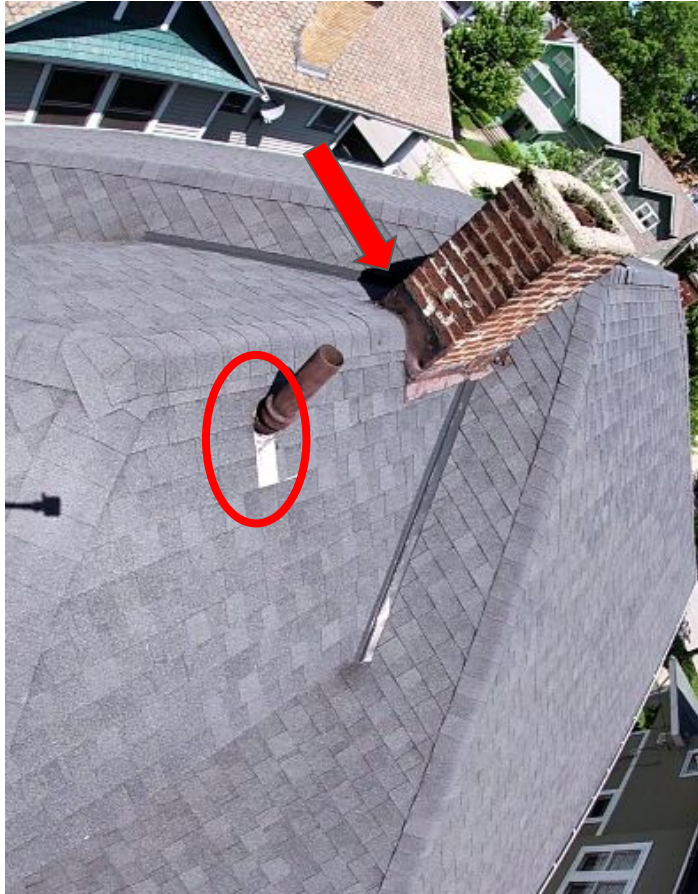
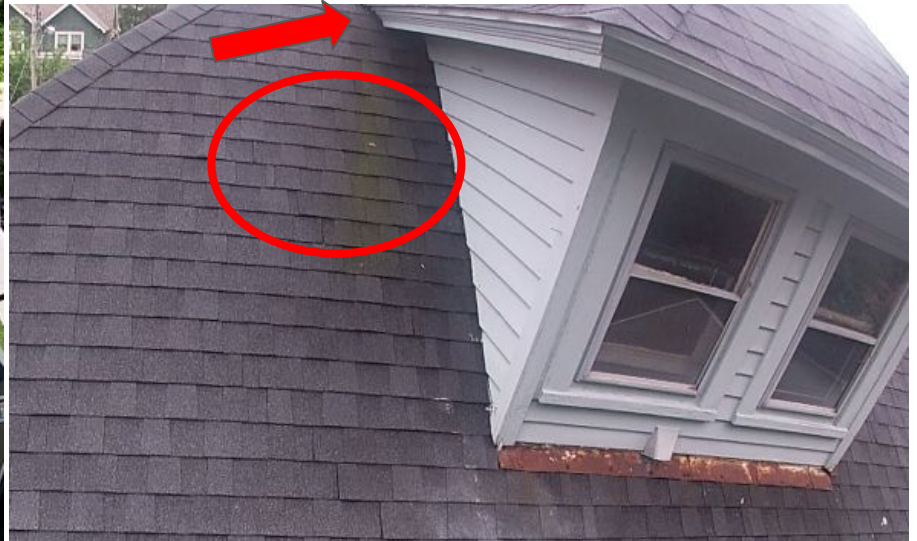
Roofing. In general the roof seems in good shape. There are many water marks. Likely the watermarks are from the time prior to the latest roof installation. Likely it was a slate roof. There are two areas that appear to currently leak. Both are circled in red below. In apartment 1236 the stack pipe appears to leak. It does not appear to have a proper boot. The other one is in apartment 1234; it is not certain as where the leak originates. The red arrows are showing likely areas. Likely it leaks at the flashing and if properly roofed there is likely much of a iceguard like material in this area. This likely directs the water to the leak area.

There are two areas that appear to currently leak. Both are circled in red below. In apartment 1236 the stack pipe appears to leak. It does not appear to have a proper boot. The other one is in apartment 1234; it is not certain as where the leak originates. The red arrows are showing likely areas. Likely it leaks at the flashing and if properly roofed there is likely much of a iceguard like material in this area. This likely directs the water to the leak area.

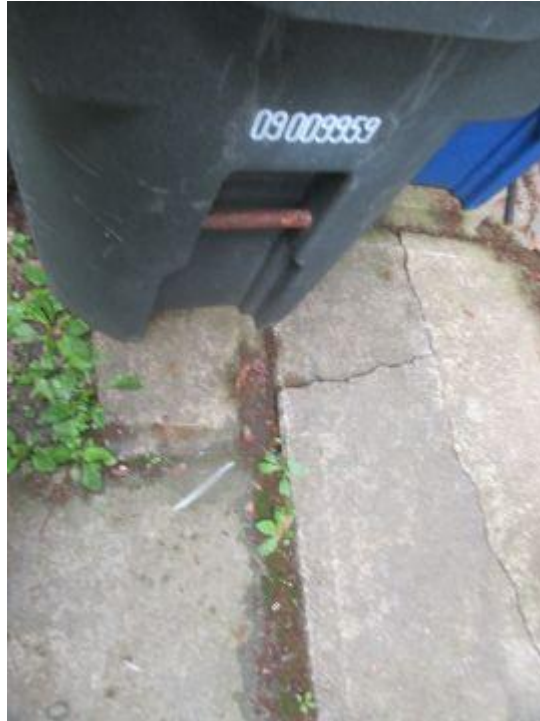
Site rear

Site. The rear sidewalk area is cracked and shifted and may be considered a trip hazard.

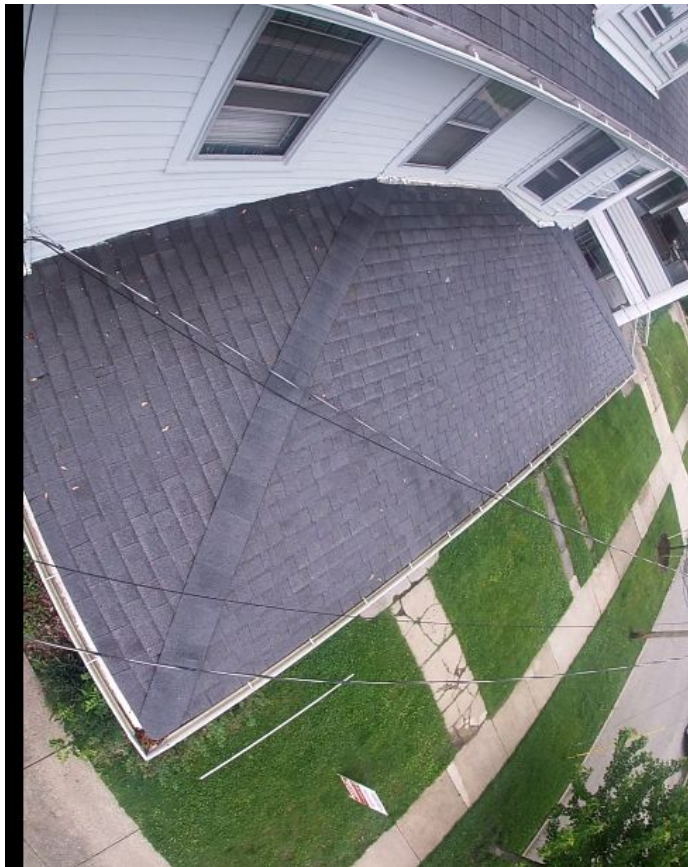
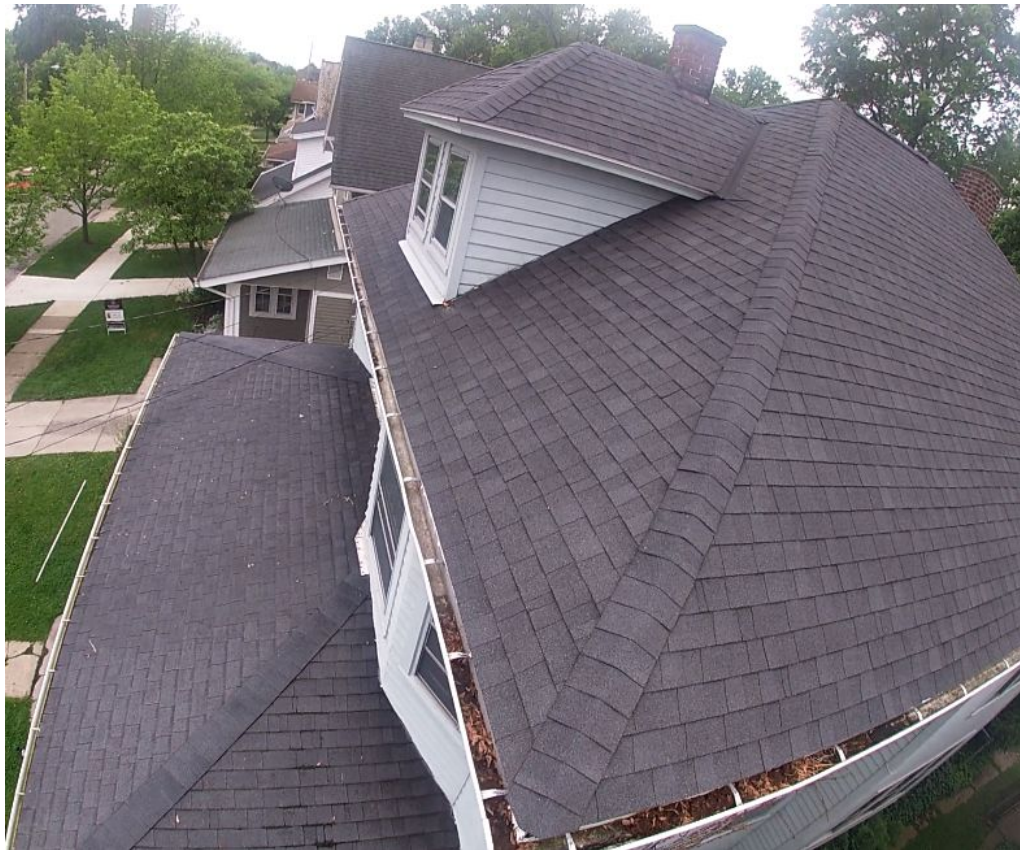
Roofing

Roofing. General front roof view.

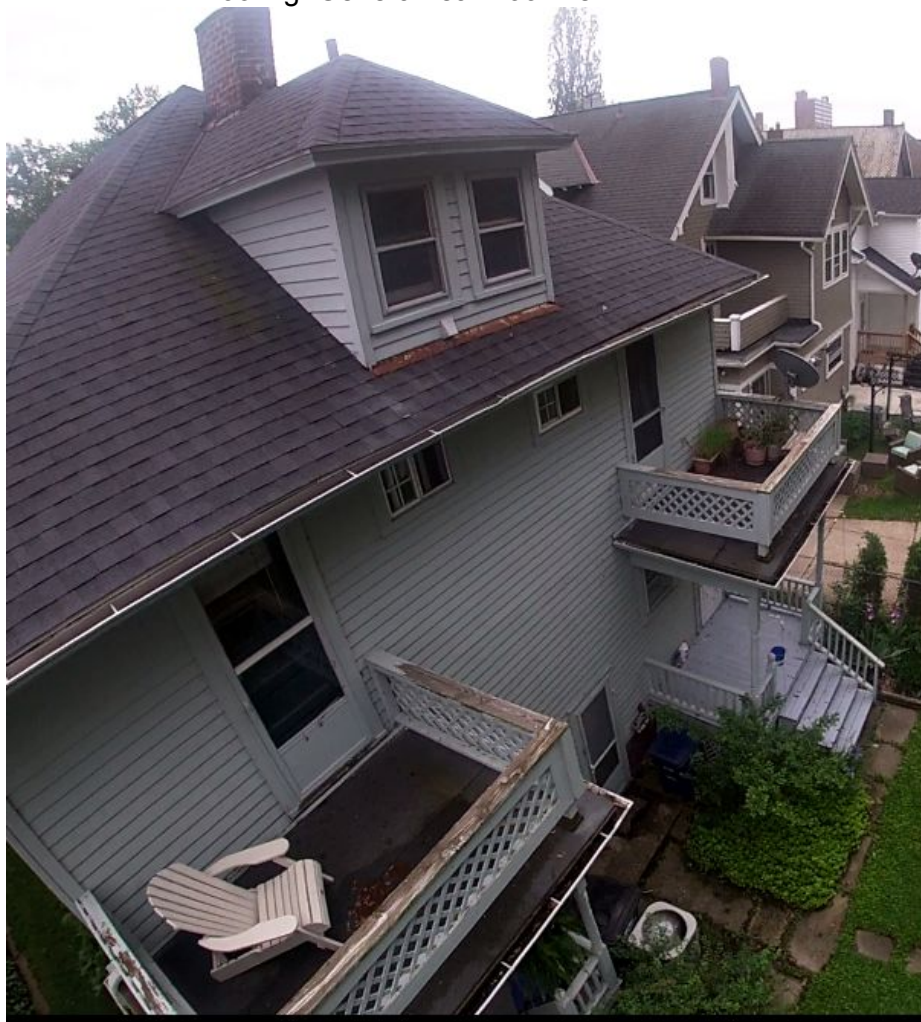
Roofing

Roofing. General rear roof view.

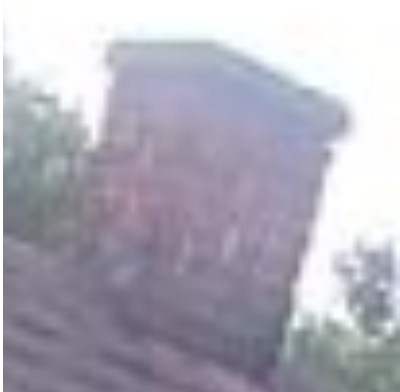
Chimney. There are two chimneys on the home. The front chimney is of little consequence. It served the fireplaces that are abandoned. It has some signs of deteriorating and may be wise to point, and cap so as not to become a hazard. Another option would be to remove it to below the roof line. Bracing may be needed in the attic. It may be wise to seal the dampers in the suites.

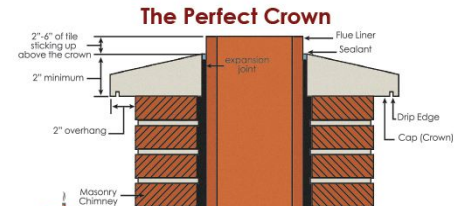
Chimney. The rear chimney has a major defect in that it has no ceramic flue liner. This chimney is in use for both furnaces and hot water tanks. Installing "B" vent liners may be the best fix. It may be necessary to brace the chimney above the roof line. Until this deficiency is removed smoke/co detectors should be installed on every floor in every suite near the chimney.(further comment in furnace section)

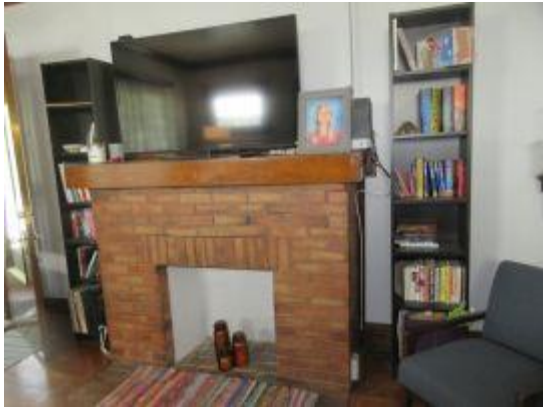
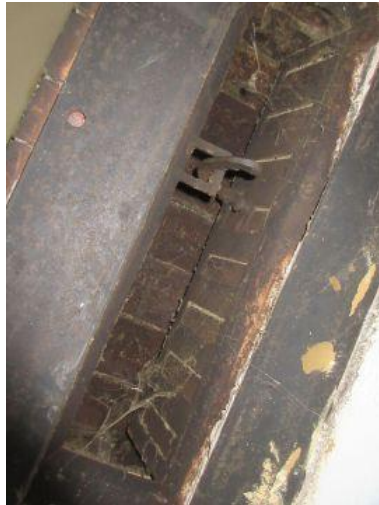
9875

~Fireplace. The fireplace appears to be an old style gas fireplace with ceramic inserts. The gas line is disconnected. The damper opens. It is not clear if the flue is open.

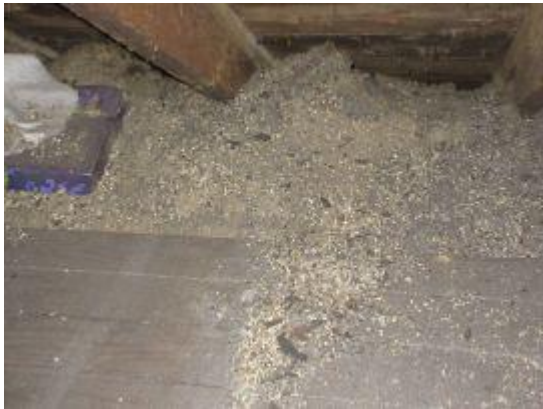
Insulation. The attic of 9875 has some vermiculite insulation. Since asbestos was mixed in with old vermiculite insulation the EPA advises to treat all old vermiculite as if it contained asbestos. There are funds available for the removal of the material under the zonolite trust.

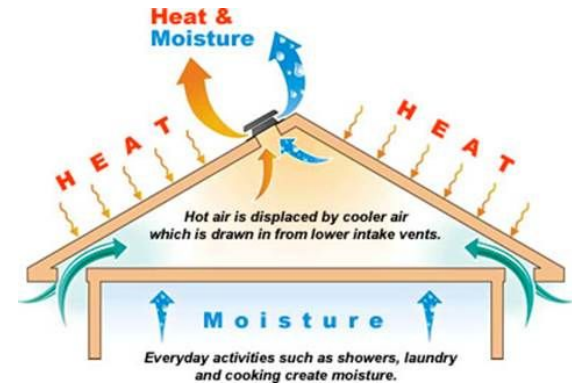
Ventilation. There is no ventilation except the windows. It is desirable to create low to high ventilation. In old construction this was not a concern.

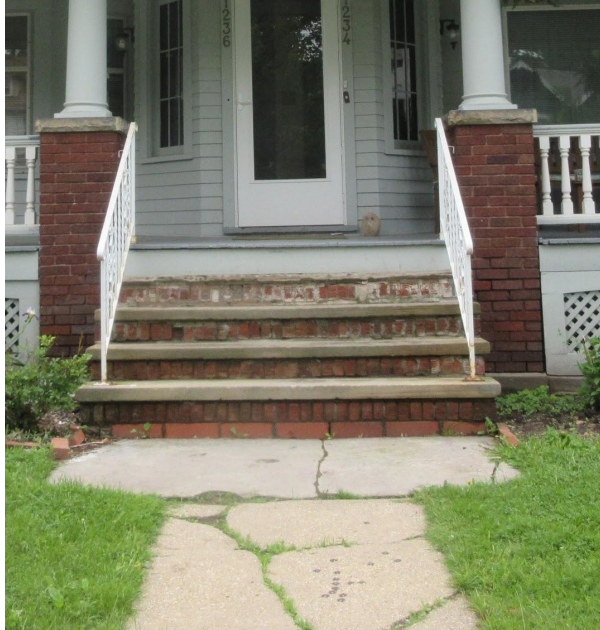
~Front Steps Like many Northern Ohio front steps and porches, these are not built or maintained to current standards.

~The sidewalk in front of the steps has settled, creating a higher than acceptable step.

The top step is very weathered sandstone and may be considered a trip hazard.

The porch ceiling shows signs of past leakage.

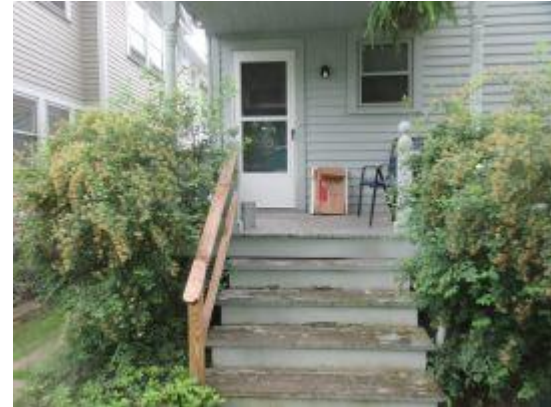
9875

- ~Rear Steps & porch. Like many Northern Ohio Rear steps, these are not built or maintained to current standards.
- ~ The step heights are not consistent.
- ~The handrail is not considered graspable.
- ~The raiser back is open more than the acceptable 4"
- ~The rail needs remounting or bracing to achieve the minimum strength standard.
- ~The bollards have open spacing more than 4" wide.

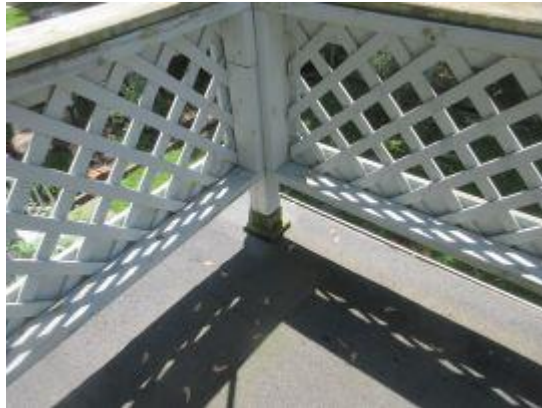
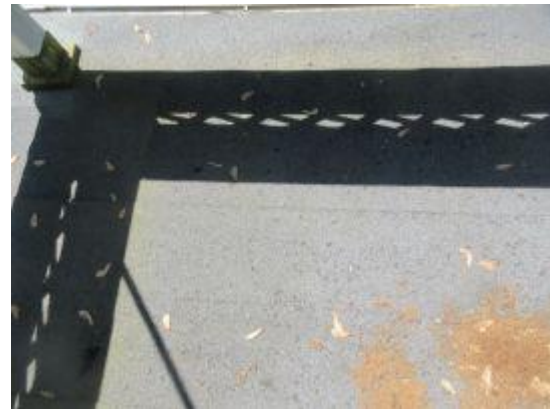
9875

Rear second floor porch. The floor is covered with roll roofing. This material is not designed for the purpose. Can I suggest covering it with rubber patio bricks. The lattice would not be considered a proper side rail. The corner posts have been spliced so likely it will not meet the minimum 200 Lbs strength standard. It is unclear how the rail is attached to the roof.

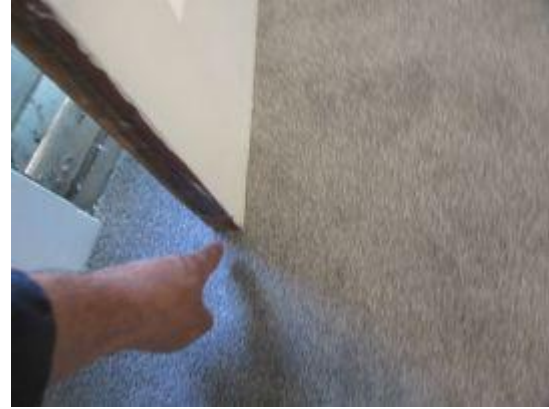
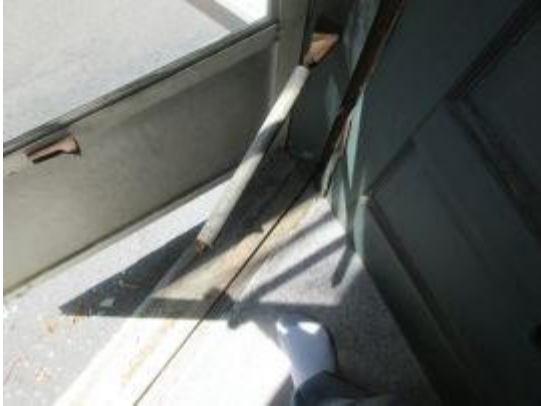
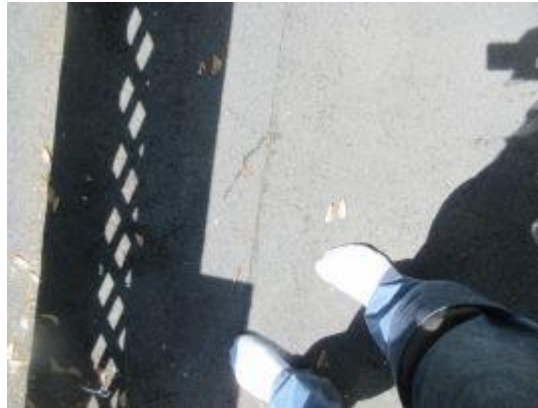
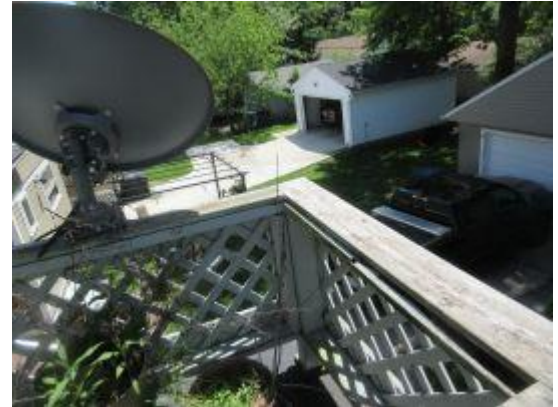
9876

Rear second floor porch. The floor is covered with roll roofing. This material is not designed for the purpose. Can I suggest covering it with rubber patio bricks. The lattice would not be considered a proper side rail. The corner posts will likely not meet the minimum 200 Lbs strength standard. It is unclear how the rail is attached to the roof. The screen door closure is detached. The door drags on the carpet.

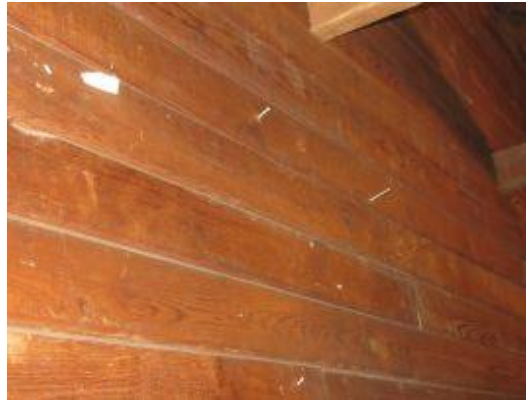
Unfinished Attic. There is some damage to the sheathing from past roof leaks. By today's standard the wall between suites would need to be of fire material and at least smoke taped. It is one sided wood plank and not smoke sealed. The only attic ventilation are the windows that mostly lack sash cords.

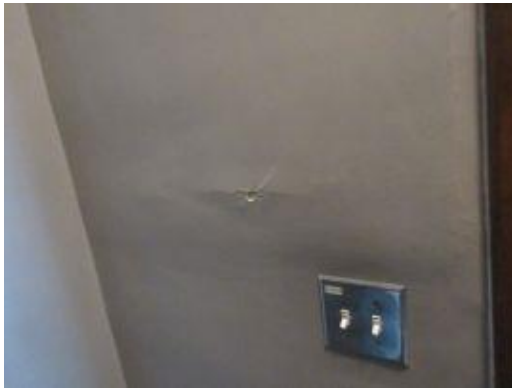
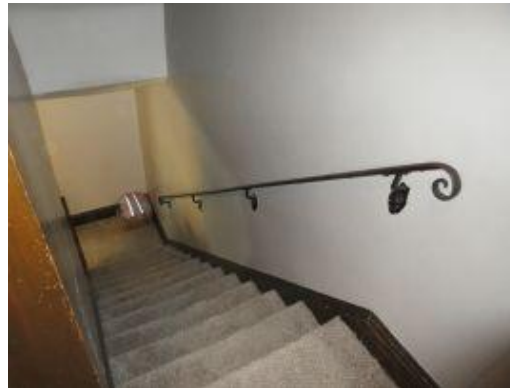
9876

~Main Steps. The following are very common step deficiencies in northern Ohio. Ultimately the local building department has final authority. I'm noting general current standards.

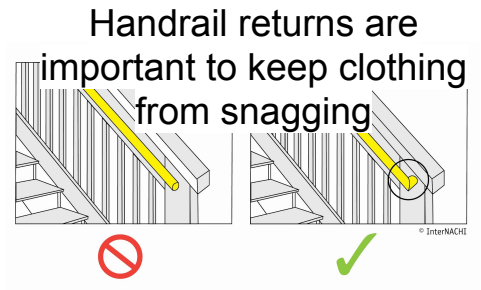
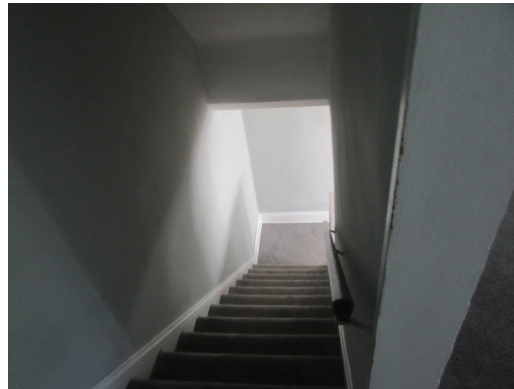
~The handrail does not return to the wall creating a clothing snag issue. However they have enlarged ends. This was a past acceptable way to deal with the problem.

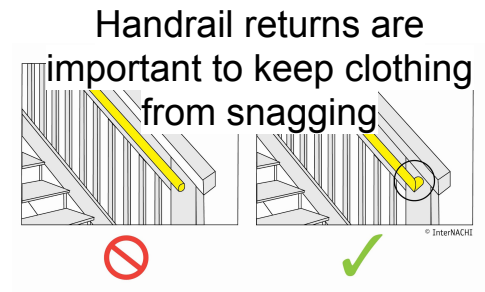
Attic Steps both

~Attic Steps. The following are very common step deficiencies in northern Ohio. Ultimately the local building department has final authority. I'm noting general current standards.

The handrail does not continue all the way to the top step.

The landing rail would require additional bracing to meet the 200 Lbs standard.

The side rail should have slats no more than 4 inches apart..

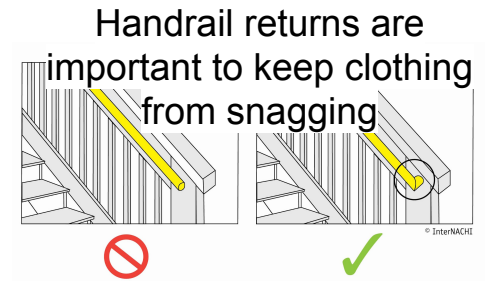
Basement steps

~Basement steps. The following are very common step deficiencies in northern Ohio. Ultimately the local building department has final authority. I'm noting general current standards.

~The handrail does not return to the wall creating a clothing snag issue.

~A side rail is missing.

The graspable handrails are missing

~The steps are steeper than current standards would allow.

The door needs to be trimmed to properly close.

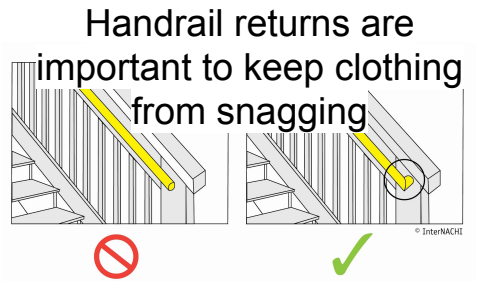
Basement

~Basement steps. The following are very common step deficiencies in northern Ohio. Ultimately the local building department has final authority. I'm noting general current standards.

~The handrail does not return to the wall creating a clothing snag issue.

~A side rail is missing.

The graspable handrails are missing from the top part of the step

~The steps are steeper than current standards would allow.

The door needs to be trimmed to properly close.

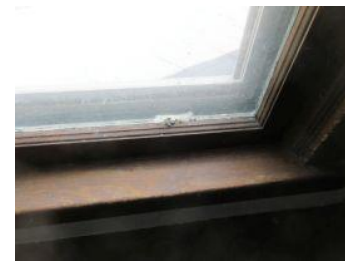
Bedroom. Throughout the apartment many windows are missing sash cords. The master bedroom window has a small chip that is filled with puddy

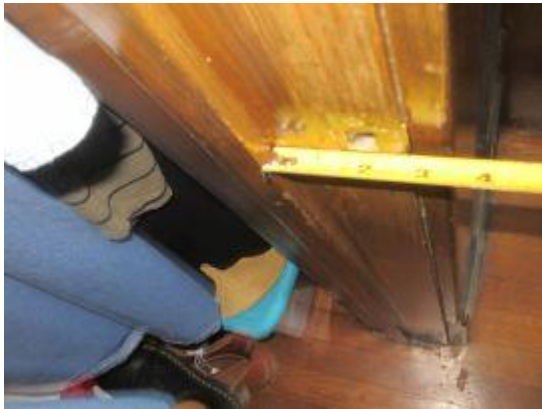
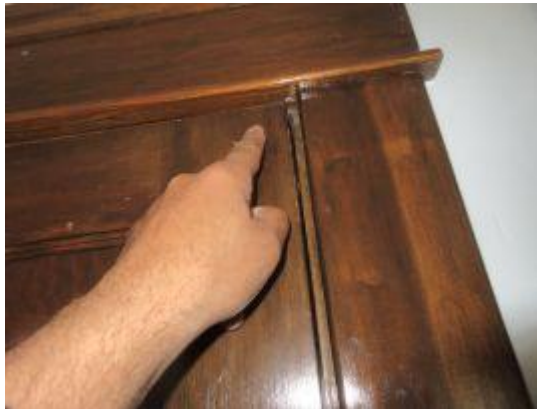
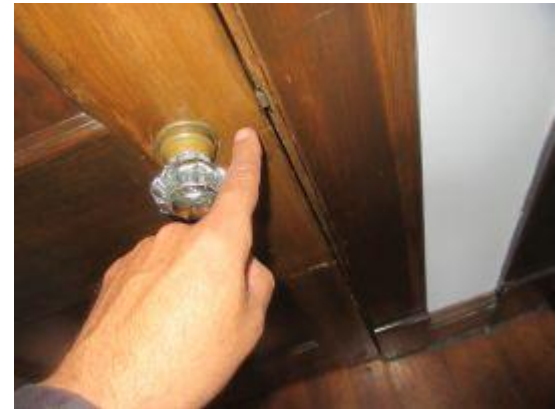
Master Bedroom. The closet door has a stop trim that is installed too deep in the door. The door needs to be trimmed to properly shut. The latch needs to be adjusted to properly latch.

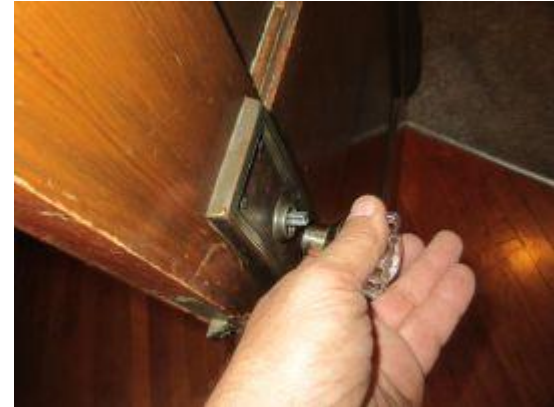
Bedroom rear The door knob to the closet is not attached.

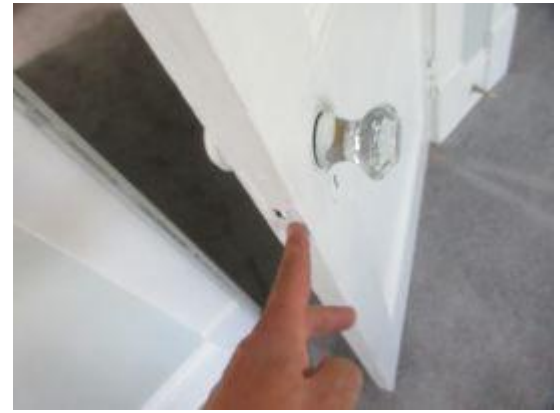
Bedroom. Most of the doors are non professionally painted. Latches are painted and will not slide. Some latch plates need adjusting. Many doors need side trimming. All need bottom trimming for the carpet. There is no in room return air grills so they need to be cut an inch above the carpet so the air can return from the rooms when the door is closed.

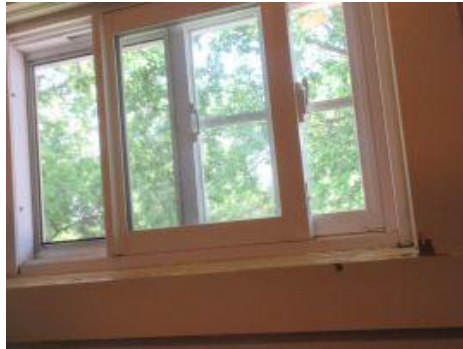
Bathroom Second floor. The window is within a bath/shower area and it should have safety glass. It appears that the window is a double hung window mounted sideways. Not a slider. It is difficult to move.

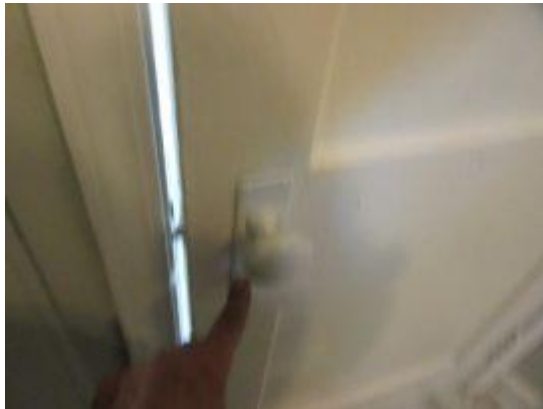
Bathroom. The latch has been painted and will not lock.

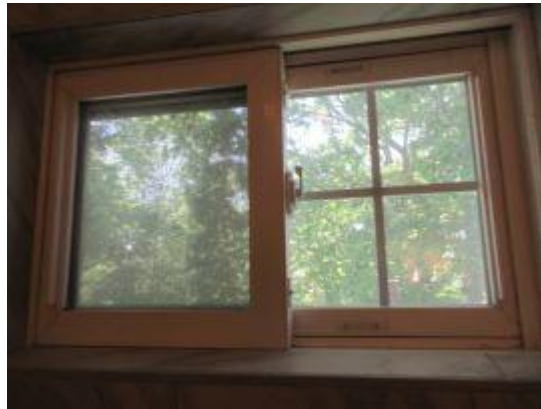
Bathroom Second floor. The window is within a bath/shower area it should have safety glass. It appears that the window is a double hung window mounted sideways. Not a slider. It is difficult to move.

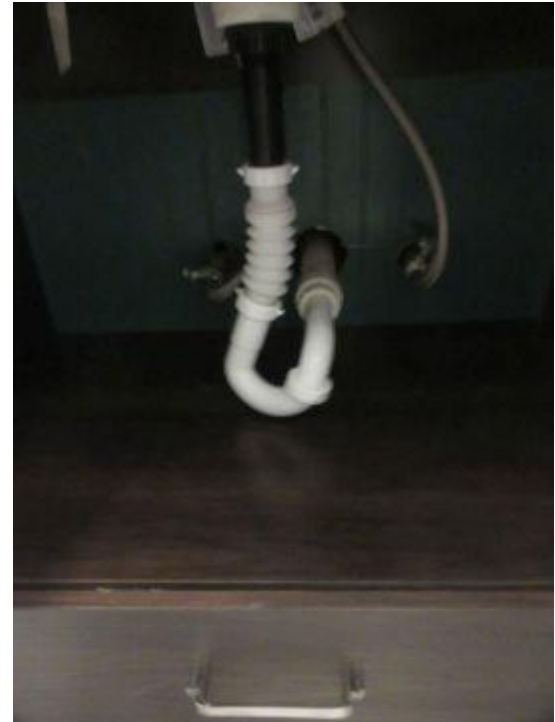
Bathroom. Flexible drain pipe should not be installed as it is prone to blockage.

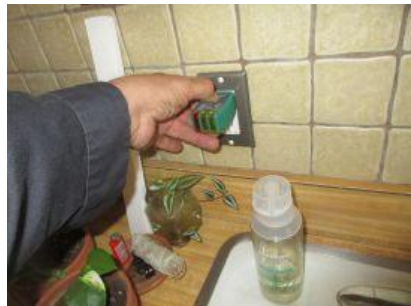
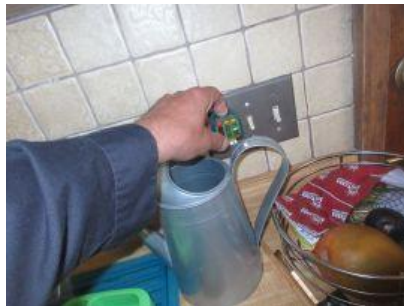
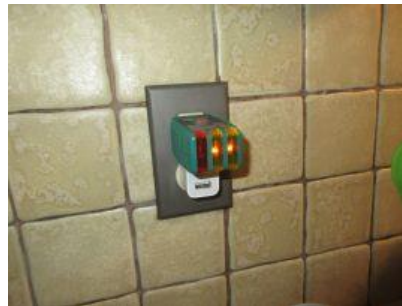
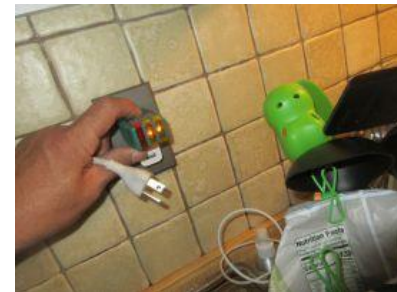
Kitchen. By today's standards all kitchen counter receptacles would be GFCI protected. The only ones here that are protected are the ones near the sink.

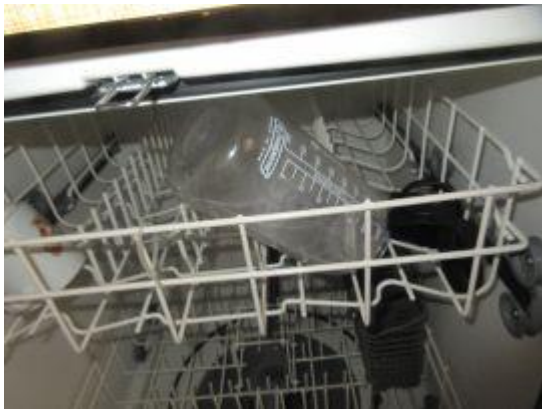
Kitchen. The dishwasher was full so it was not run.

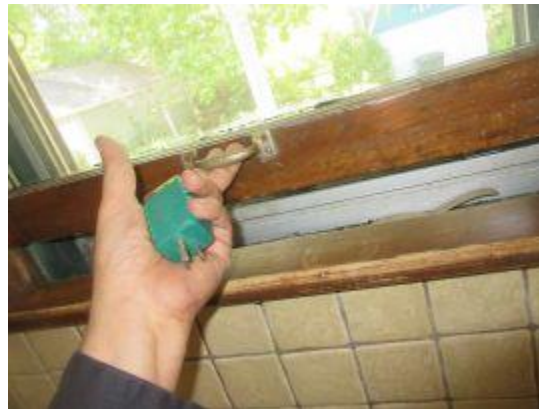
Kitchen. The kitchen window has no sash cords.

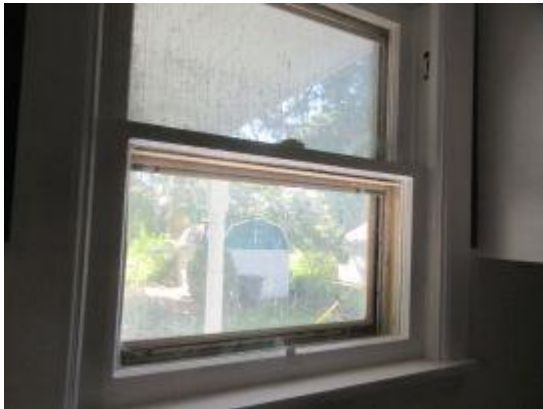
Kitchen. The kitchen window is painted shut.

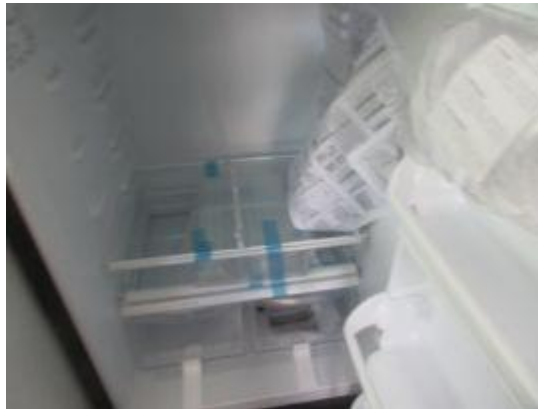
Kitchen. as mentioned elsewhere the stove and refrigerator are not fully assembled.

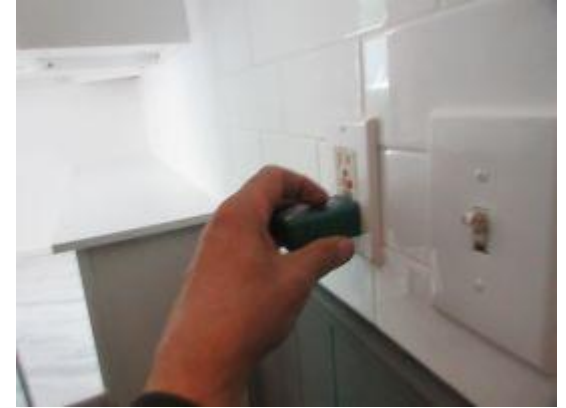
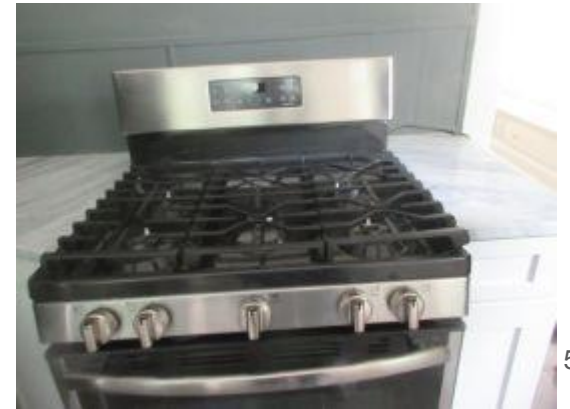
Kitchen. 1236 There is a GFCI protected receptacle for the refrigerator. Unfortunately the light switch is also behind the refrigerator. This is an inconvenience more than anything else.

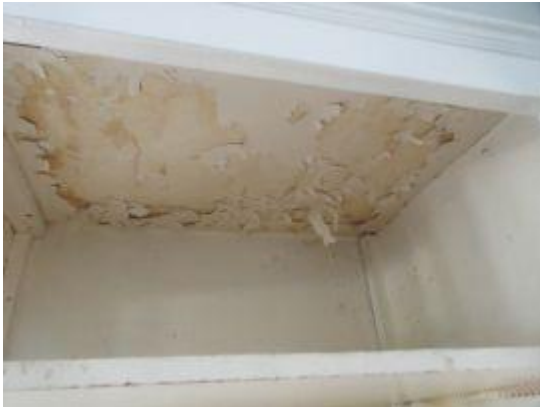
Dining Room. The china cabinet has peeling paint. This may be a large issue because of the concern about lead.

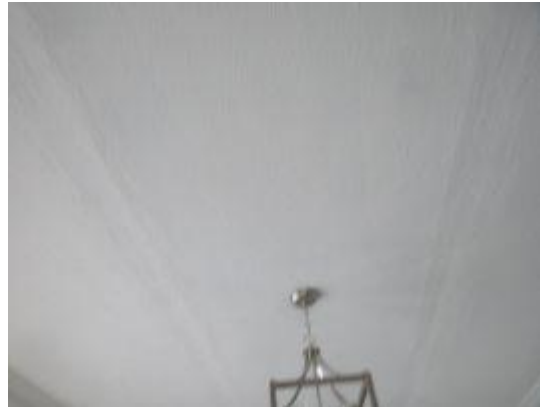
Dining Room. The ceiling appears to have been re-drywalled. The taping is not professional.

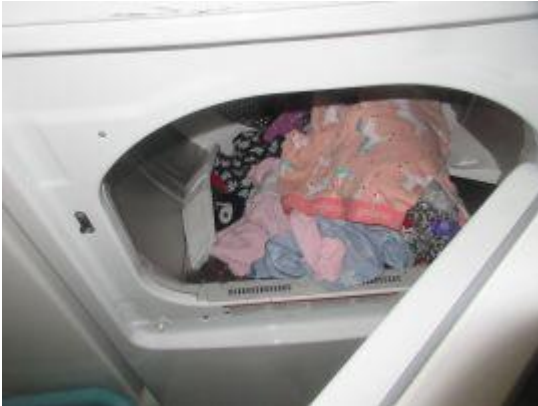
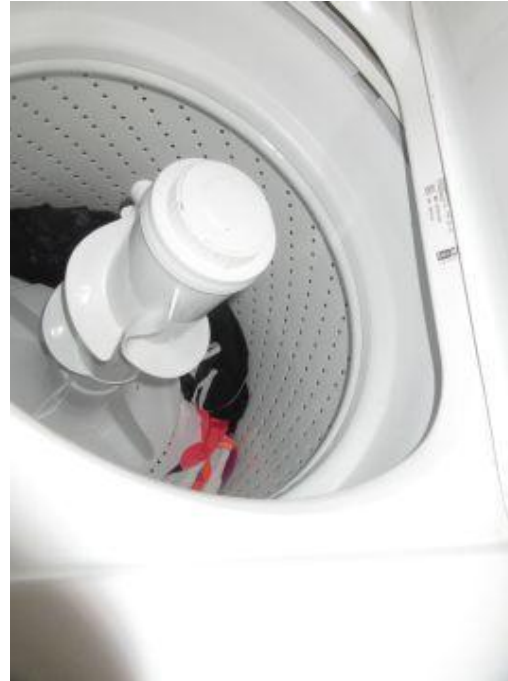
Laundry. BOTH THE WASHER AND DRYER WERE FULL SO THEY WERE NOT RUN.

A receptacle must be installed in a laundry. Since 1975 it must be GFCI protected within 6 feet of the edge of the sink bowl. Currently all laundry receptacles must be GFCI protected. Local authority may waive GFCI requirement for dedicated outlets.

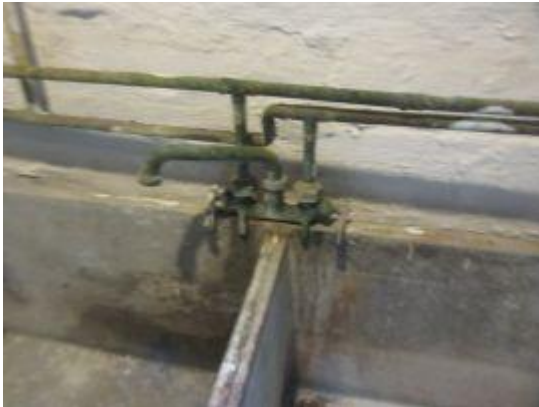
Laundry. The faucet for the laundry sink dropped.

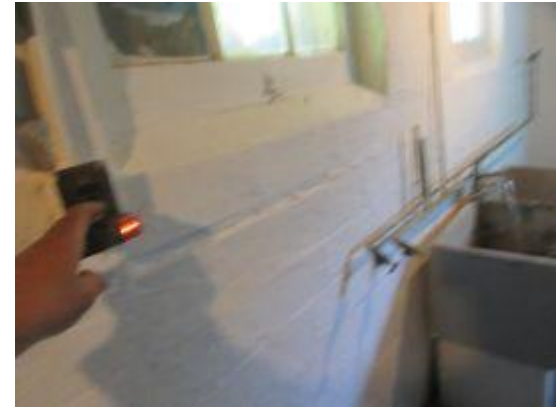
Laundry. The receptacle is within 6 foot of the laundry sink. It should be GFCI protected.

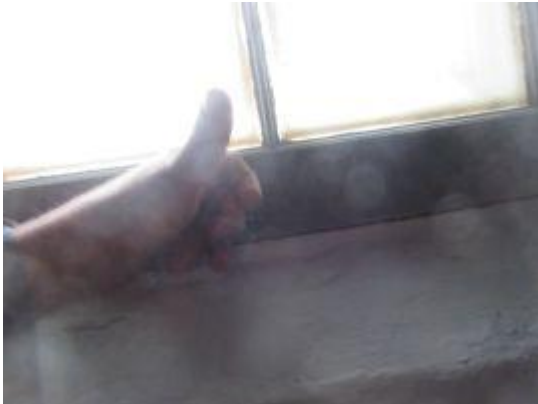
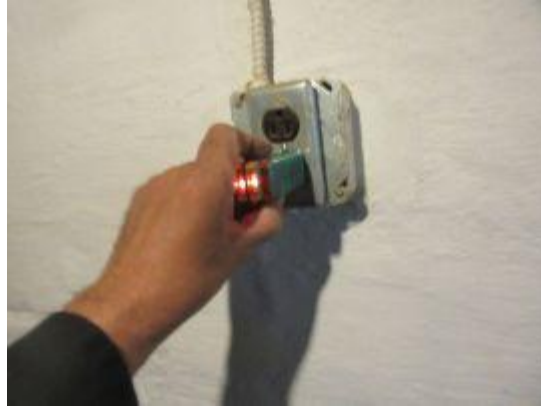
~Interior unfinished basement At least 1 receptacle must be installed in a basement. Since 1987 all unfinished basement receptacles must be GFCI protected. Local authorities have tremendous leeway in interpretation and enforcement.

Unfinished Basement. In both apartments the basement receptacles were not GFCI protected. Also, the windows were inoperable.

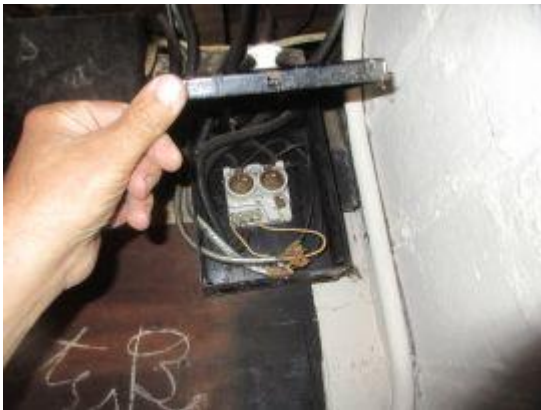
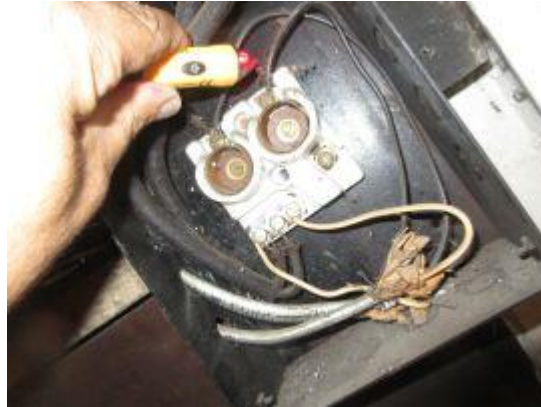
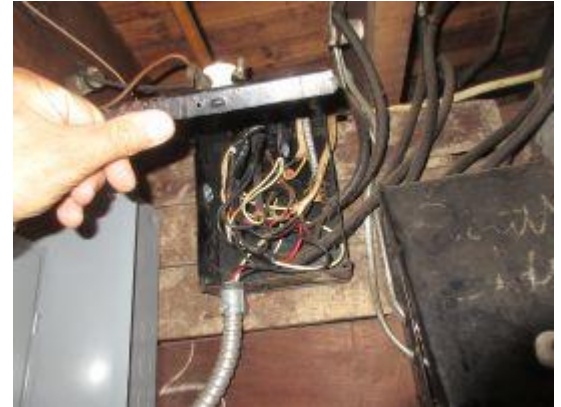
Electrical. 1234. There are 2 old fuse boxes that are being used as junction boxes. Both need to be screwed shut. The one on the right has 2 wires under a screw attachment being used as a wire joint. This is a bad practice. It leaves exposed live metal surfaces. They should be removed and made up with a wire nut.

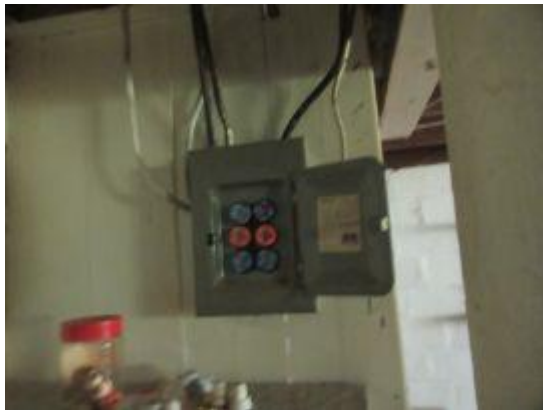
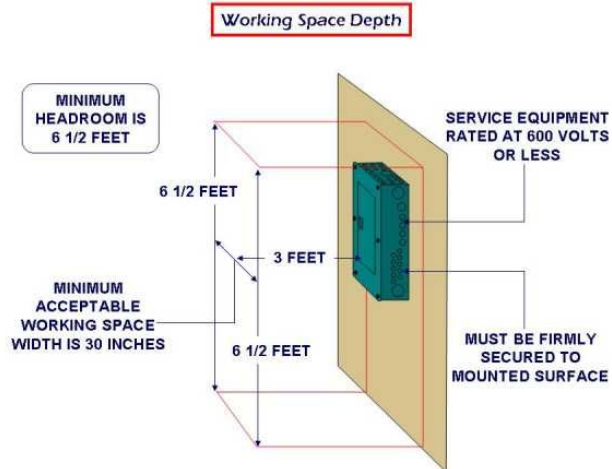
Electrical 1236. There is a functioning fuse box. It is installed in the shelves. This violated working clearance requirements and due to its closeness to the shelf, I could not open the cover. Also, though fuses are a more reliable system, insurance companies often take exception to them in homes.

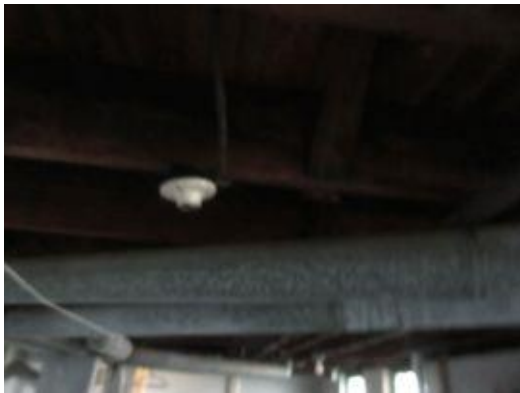
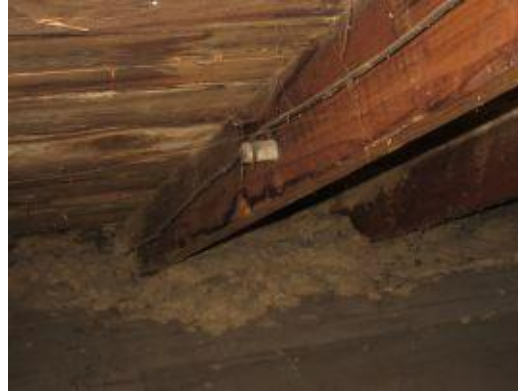
Electrical 1234. There is a lamp holder that is broken and needs replacement. Heat and amperage is the enemy of all older wiring. I recommend the replacement of any incandescent lamps with LED or compact fluorescent to greatly reduce both heat and load.

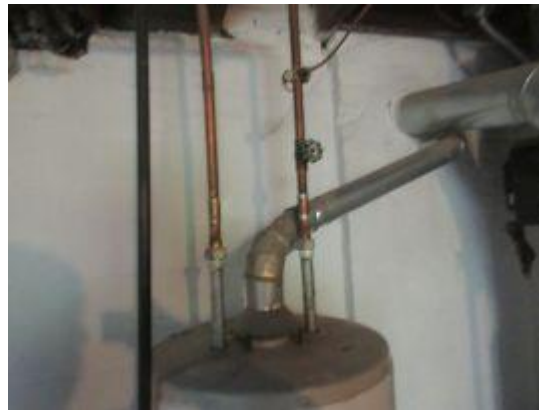
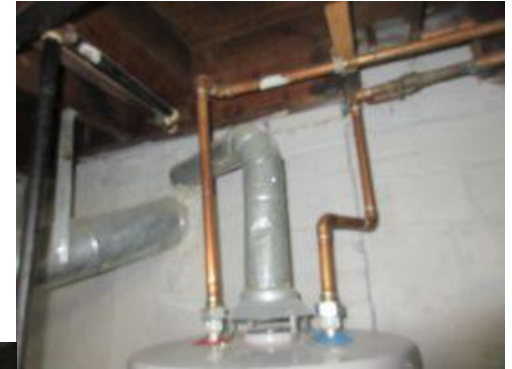
~~Electrical BOTH. The hot to cold water lines are lacking a bonding jumper. Hot water tanks have dielectric fittings so the hot water system may not be grounded and this may allow it to be energised without tripping a breaker.

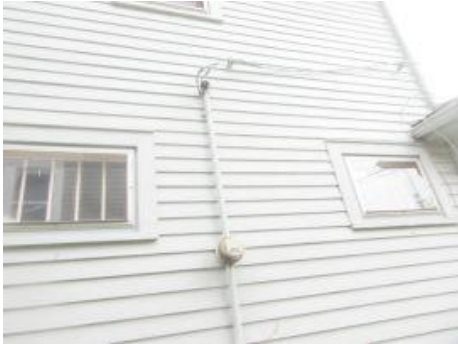
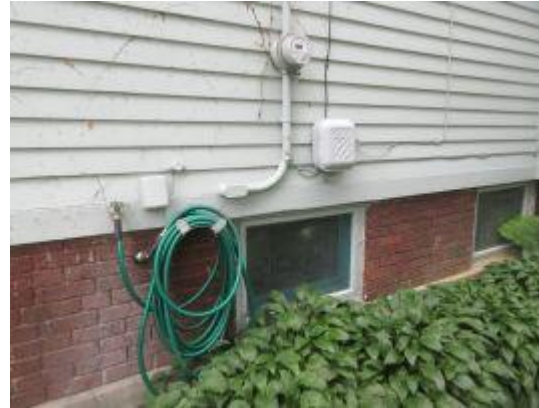
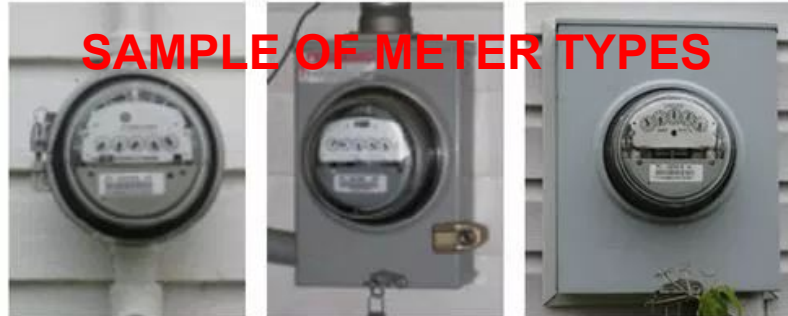
~~Electrical BOTH. There appears to be no evidence of a ground rod.

~~Electrical BOTH. The majority of round meter bases are 60 amp. The panel has a 100 amp main breaker. Most likely the panel has been changed out without changing the meter base.

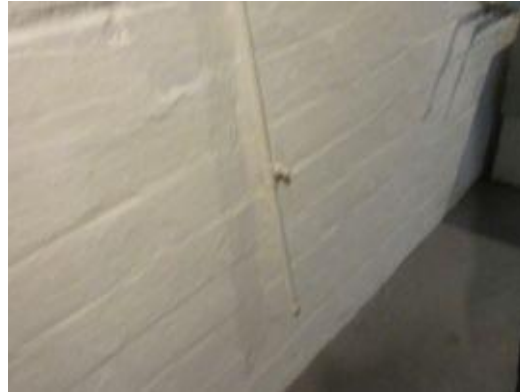
Plumbing Laundry area 1236. Most gas utilities require that as appliances are replaced, the old style gas valves are replaced with ¼ turn AGA approved gas valves.

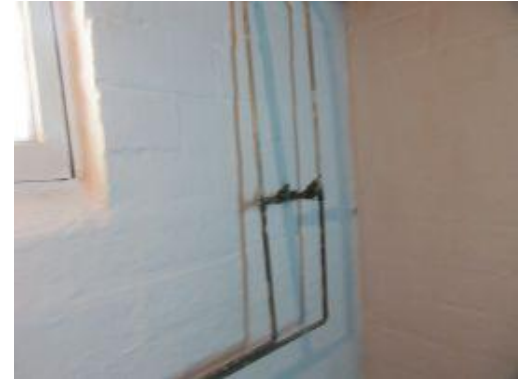
Plumbing. Both basements have older globe valves. Some are missing handles. Likely some will not work or will leak once operated. There may be additional old style gas valves which I did not note

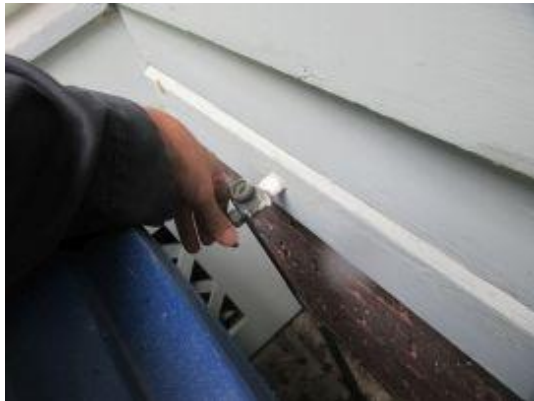
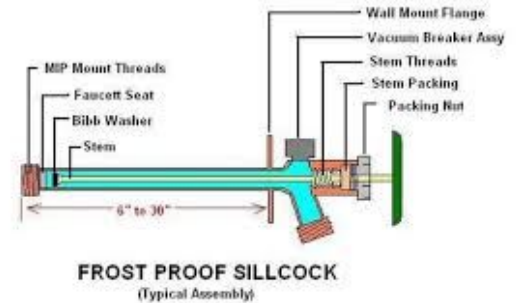
Plumbing. The outside hose spigots are not frost free type and so they should be turned off and drained for the winter.

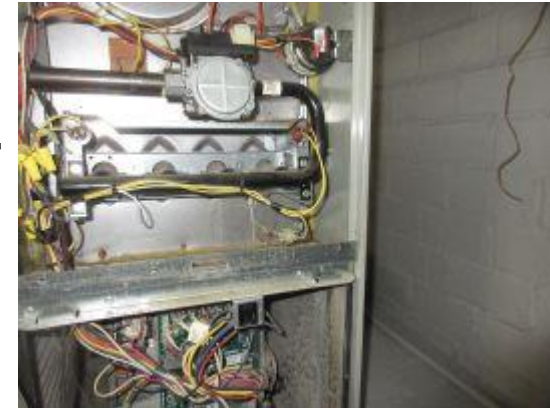
Heating. Both furnaces have Bayvent kits added. Their primary use is to reduce the moisture from flue gases in a chimney that condense on the cold side of exterior chimneys. This chimney is in the interior of a home. So likely the devices were installed to attempt to deal with the deficiency of the chimney not having ceramic flue liners. With no liner, flue gases can leak into the home. With one large chimney opening instead of 2 smaller liners likely the gases do not properly exhaust fully up the chimney. This results in highly acidic water condensing in the chimney further decaying the chimney. It may also allow flue gases to leach back into the basements. A licensed contractor should further analyze the situation. And will likely suggest the addition of flue liners within the chimney .

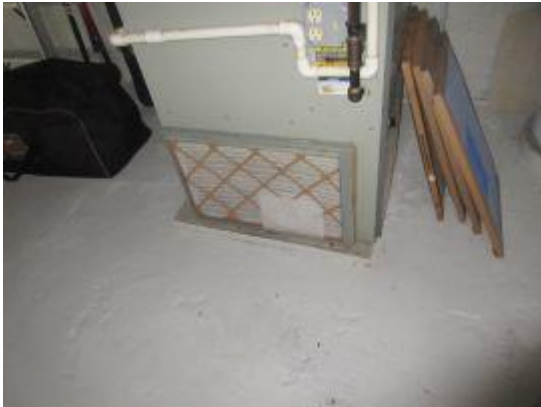
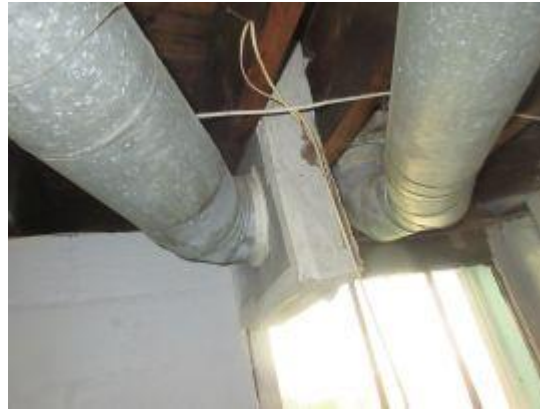
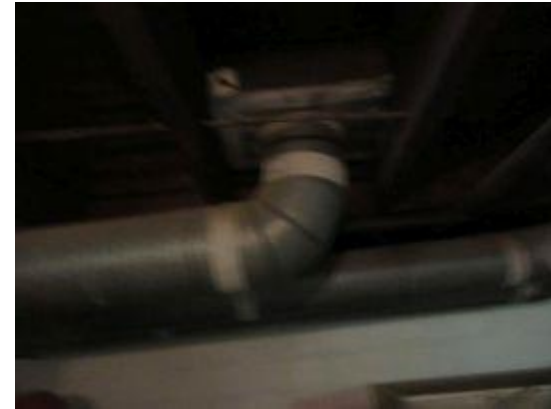
Heating. Both furnaces have furnace return air ducts open to the basement. This leaves the fan open simply by removing the filter or pushing the filter in. Children or pets can be injured from the unguarded fan. An inexpensive bird screen can be fashioned and attached over the filter and keep children and pets safe. The furnace in 1236 has a fan safety switch that is not shutting off the fan when the cover is removed.

Heating/cooling 1234. It appears that there is no return diffuser/duct to the basement. This may reduce efficiency and can also create negative pressure drawing exhaust fumes into the basement and the air supply.

Heating. Likely the white duct tape and insulation contains asbestos. As long as it is not cut, removed, scratched or falls off it is of little risk.
