XXXXXX 9876

● Statistics 1

Prepared by: Jerry Salontay

Ohio Home Inspectors LLC.

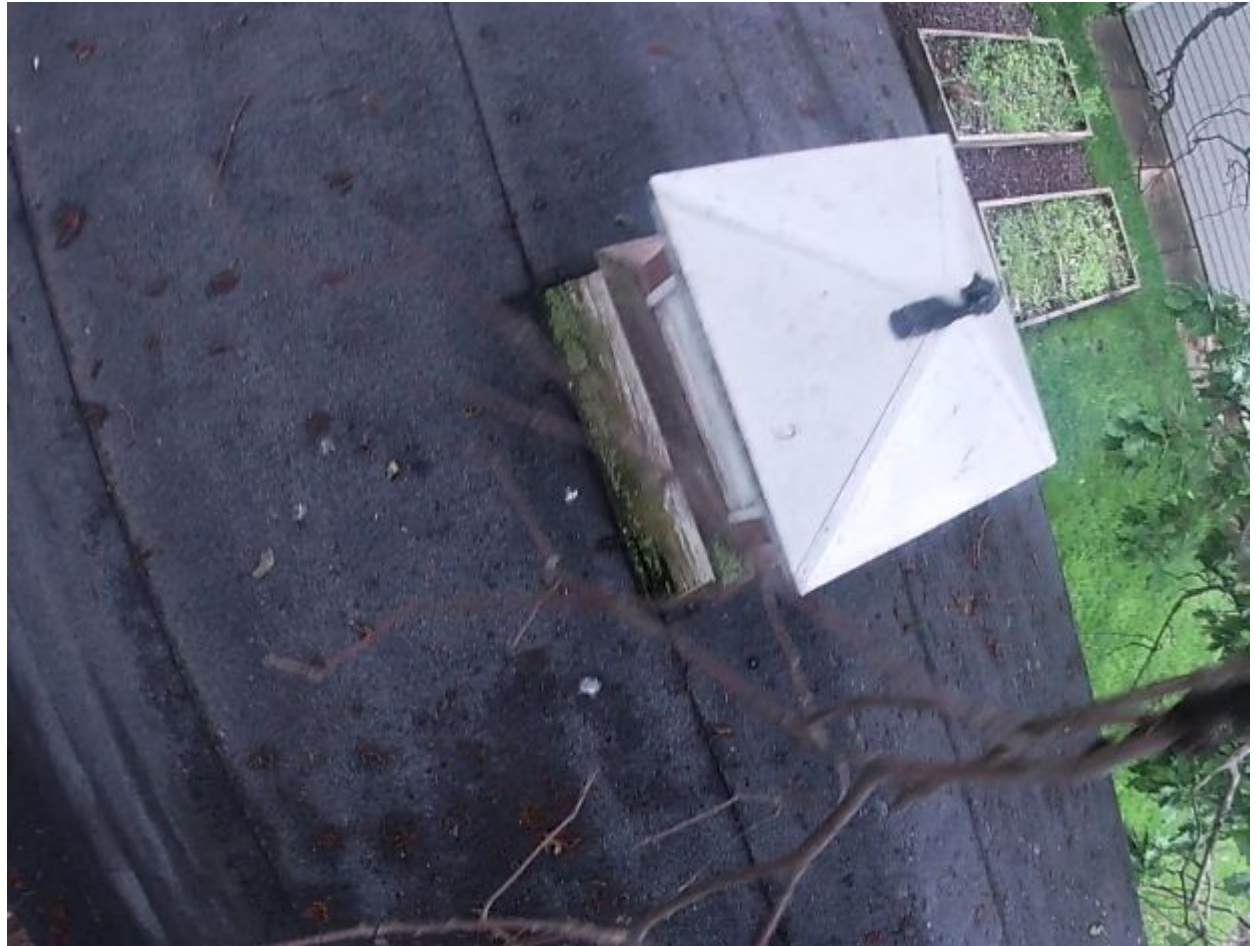
Shed. Picture of roof of shed.

Shed. The shed needs some TLC. The coupla is decaying and leaking. The roof needs replacement It is heavily moss covered and leaking. The siding is pine and decaying . The window is missing glass and allows birds in. May I suggest covering both walls and roof with metal roofing. If city accepts it would be a durable inexpensive solution. And comes in many colors
