● Statistics 1

Ohio Home Inspectors LLC.

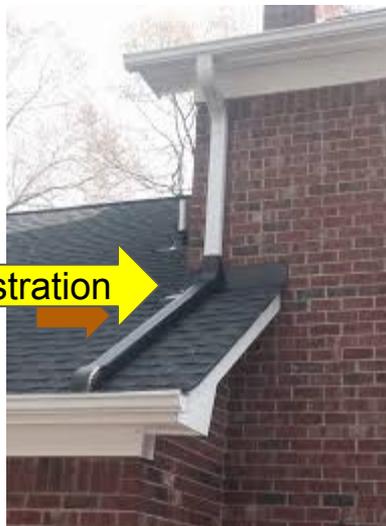
Illustration

~Roofing. Though it is very common practice in Northern Ohio, when downspouts terminate above a lower roof, a downspout pipe should be run along the roof to a lower gutter. It should never be allowed to direct the water horizontally against the roofing material.

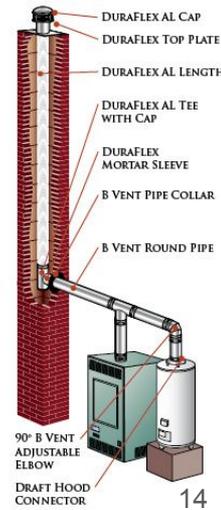
Chimney. It appears that a metal flue liner had been added for the hot water tank.

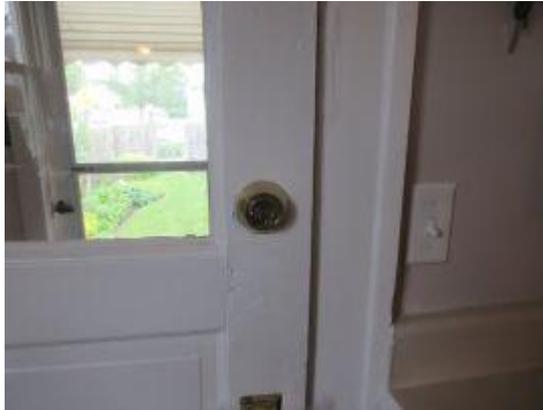
Rear porch. The door has a double keyed deadbolt. This is no longer permitted in Ohio in residences. Until it can be changed a key should be left in it whenever anyone is home.

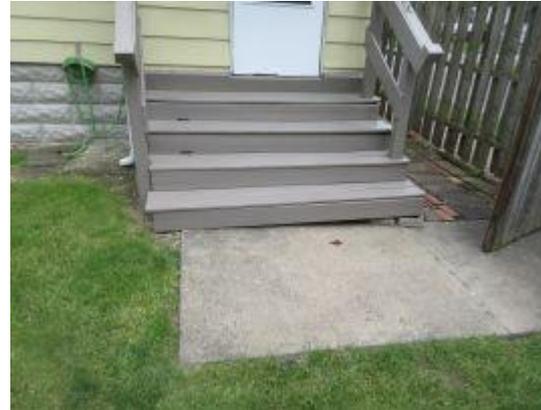
~Rear Steps & porch/deck. Like many Northern Ohio Rear steps, these are not built or maintained to current standards.

~The sidewalk in front of the steps is not level creating a higher than acceptable step.

~The rail needs remounting or bracing to achieve the minimum strength standard.

~The bollards have open spacing more than 4" wide.

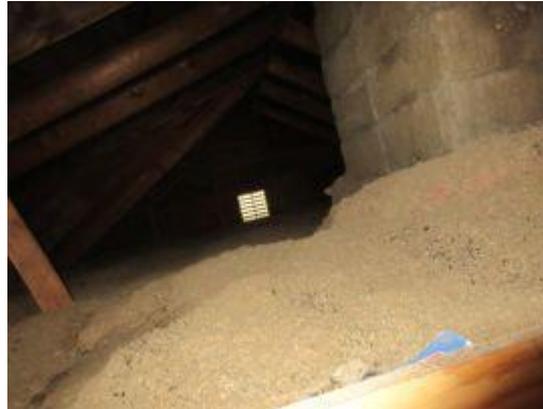
~The attic is confined. Inspector has judged it is practical and safest to inspect only be from the edge of the scuttle hole.

Unfinished Attic. The hatch way is small and difficult to crawl through. The support members are covered and difficult to find for standing.

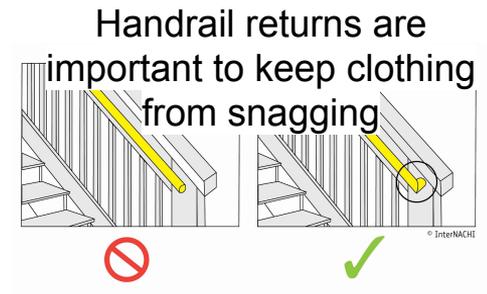
Main steps

~Main Steps. The following are very common step deficiencies in northern Ohio. Ultimately the local building department has final authority. I'm noting general current standards.

~The steps are steeper than current standards would allow.

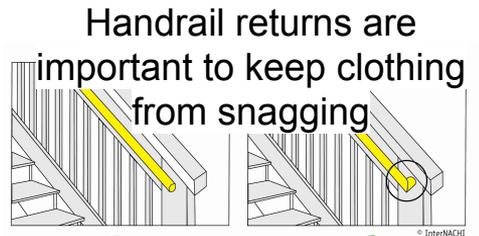
Basement steps

~Basement steps. The following are very common step deficiencies in northern Ohio. Ultimately the local building department has final authority. I'm noting general current standards.

~The handrail does not return to the wall creating a clothing snag issue.

~A side rail is missing.

~The lower handrail is missing.

~~The door in the stairwell has no safety glass.

The height and depth of the steps are not even.

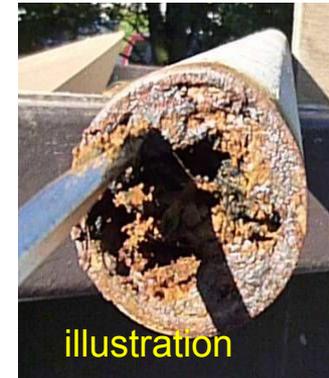
Bathroom Second floor. The tub drain is slow. Likely a hair clog. It too can be that there is steel drain pipe in the walls which rusts from the interior out and tends to clog. There appears to be putty on the drain pipe and many towels pushed in to surround it. The towels felt moist. The hot water valve had no stop; you can rotate it around and around. The tub surrounding the pipe has been painted black. Perhaps to seal the plumbing.

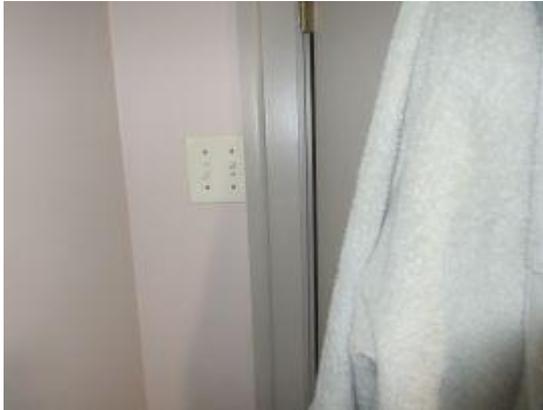
Basement Bathroom. The switches are wrongly installed behind the door.

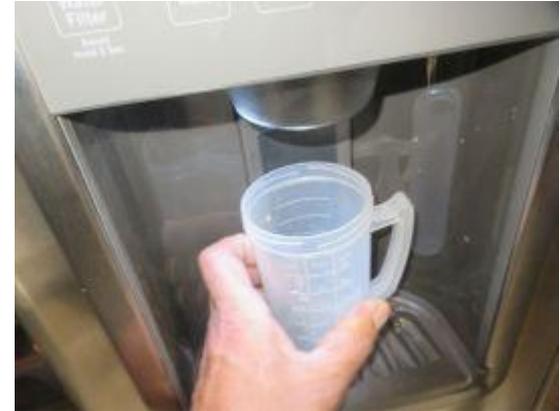
Kitchen. The water line is not connected to the refrigerator.

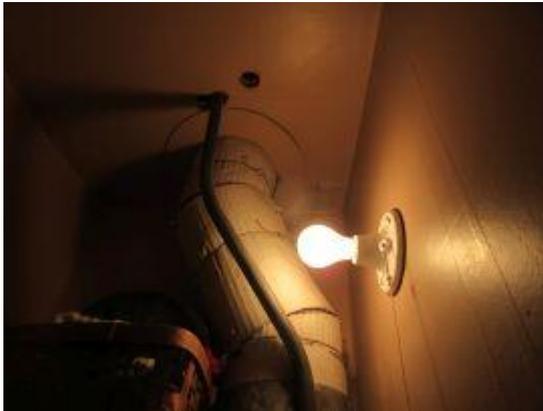
Living Room. In the closet a supply air duct to the master bedroom has been added. It appears to have an insulation that likely contains asbestos. The incandescent light should not be located in the clothes closet. For safety the least that can be done is to use LED light bulbs.

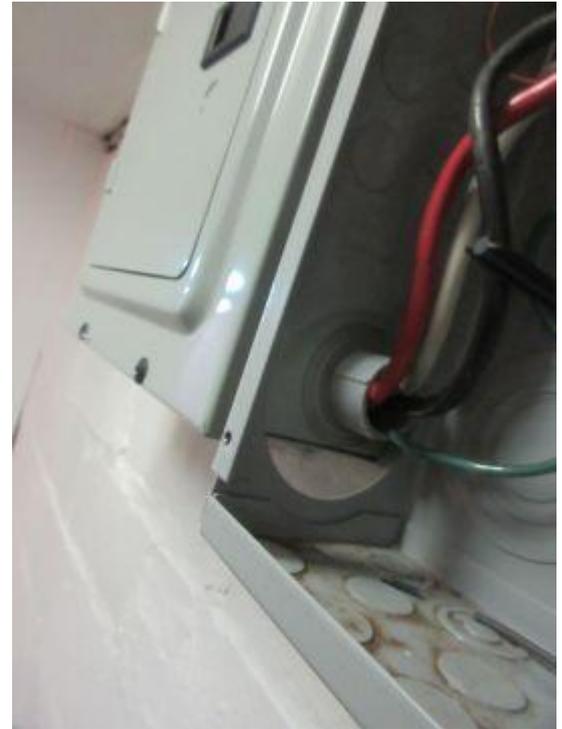
Electrical. The sub panel is fed without a proper fitting leaving a large opening in the main panel.

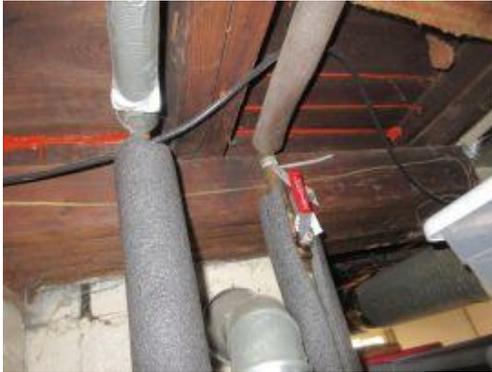
~Electrical. The hot to cold water lines are lacking a bonding jumper. Hot water tanks have dielectric fittings so the hot water system may not be grounded and this may allow it to be energised without tripping a breaker.

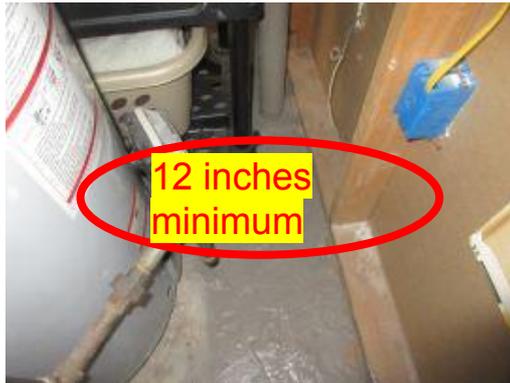
Plumbing. In general there is a 12" minimum clearance requirement for the front of how water heaters.

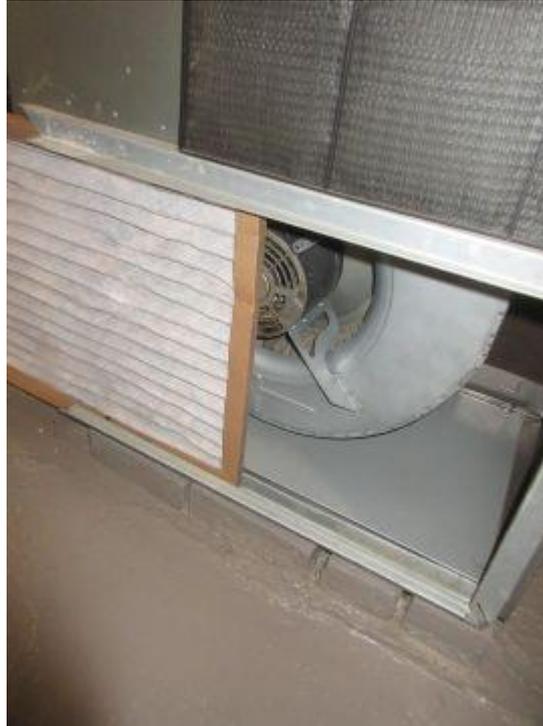
Heating. There should be a bird screen over the filter so kids and pets can not get to the cage fan.
